Appendix 7.2

Photographic Record

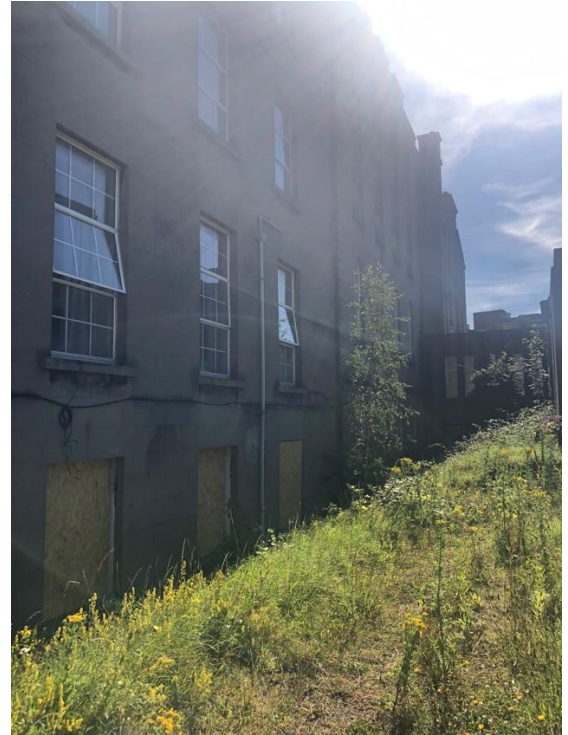
Plate 15: The rendered south elevation of the rear extension

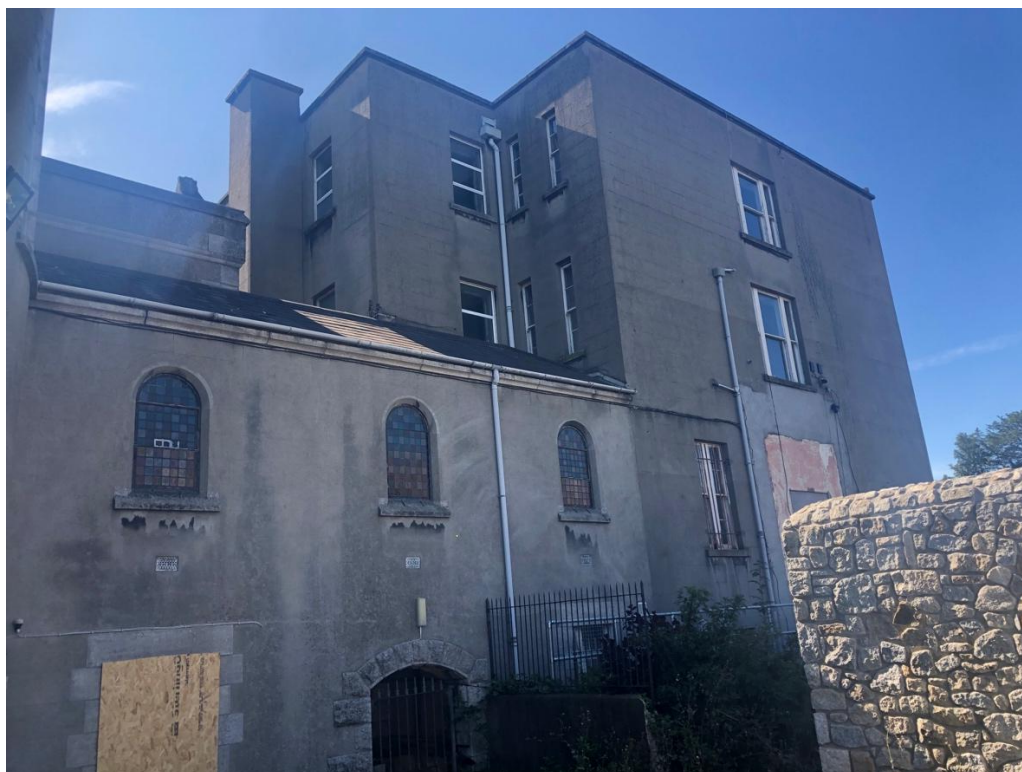
Plate 21: North-west elevation of link between rear of MPH extension and Chapel. Rusticated stone surround to gated passage to central courtyard. New boundary wall, part of recent separation works, in foreground.

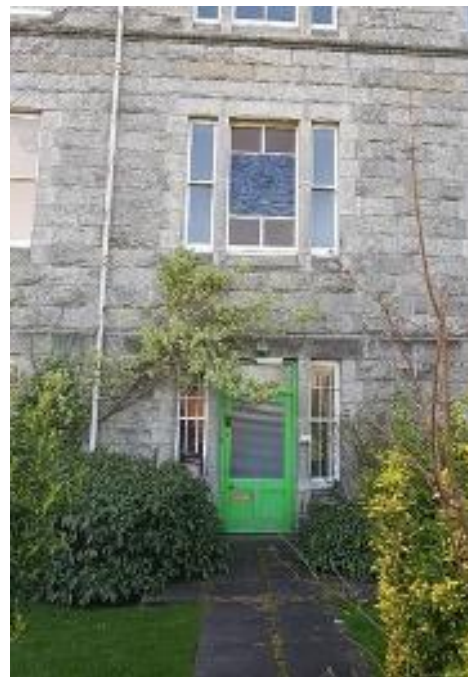
Plate 30: Side door of Tabor House with stained glass on first floor, a later modification

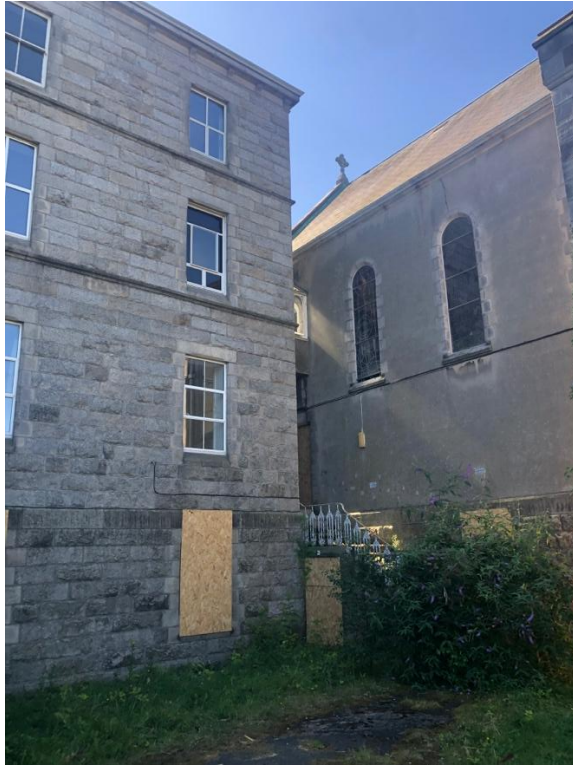
Plate 31: Connection of Tabor House to the later Chapel: comprising a set of stone steps to first floor level, and a glazed link at second floor to the mezzanine at the rear of the Chapel

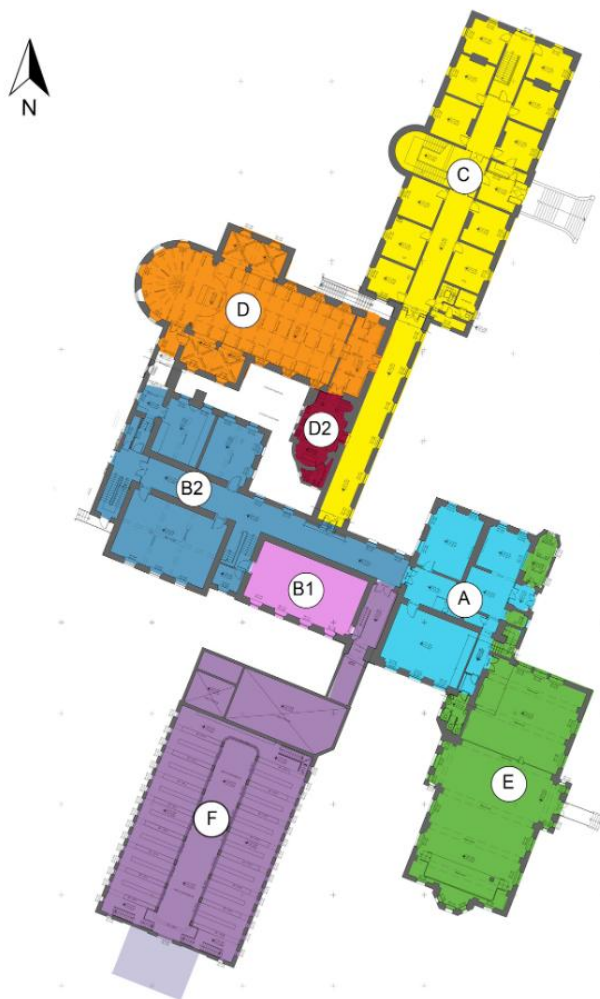
- A Milltown Park House
- B Rear Extension
- C Tabor House
- D Chapel
- E Finlay Wing
- F Archive

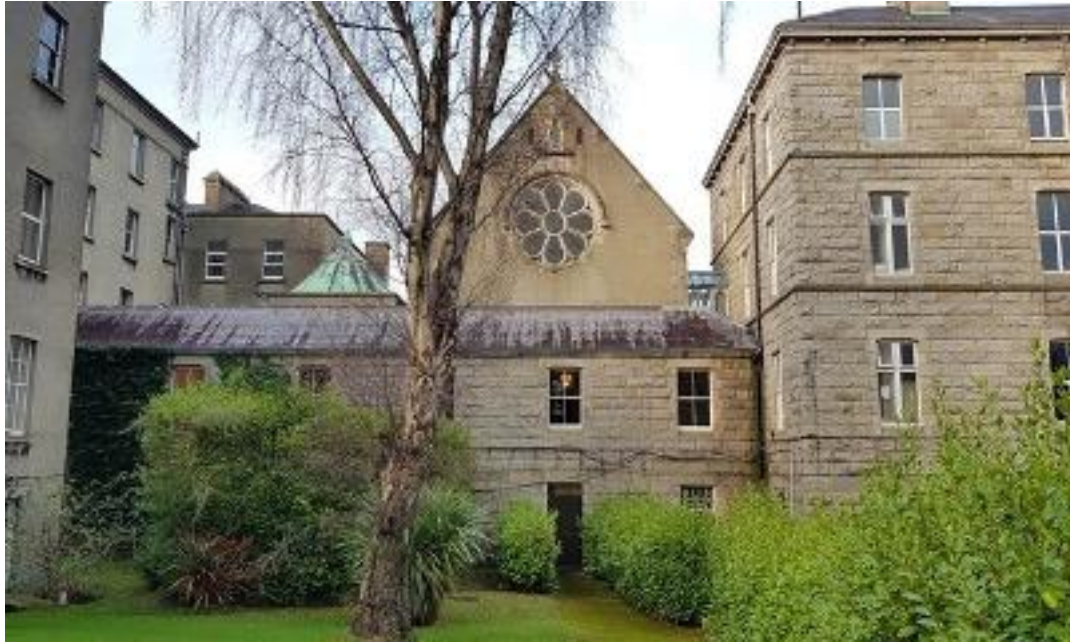
Plate 33: (2023 image included for clarity) Front elevation of Chapel, above linking building, with stained glass Rose window on east gable with copper turret of Sacred Heart Chapel south of it. Both Chapels are accessed from within Milltown Park House.

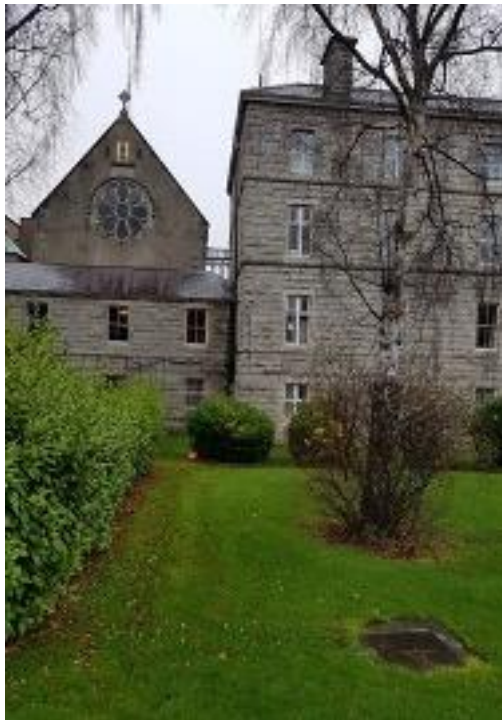
Plate 34: (2023 image included for clarity) Wider view of Chapel link front to Tabor House

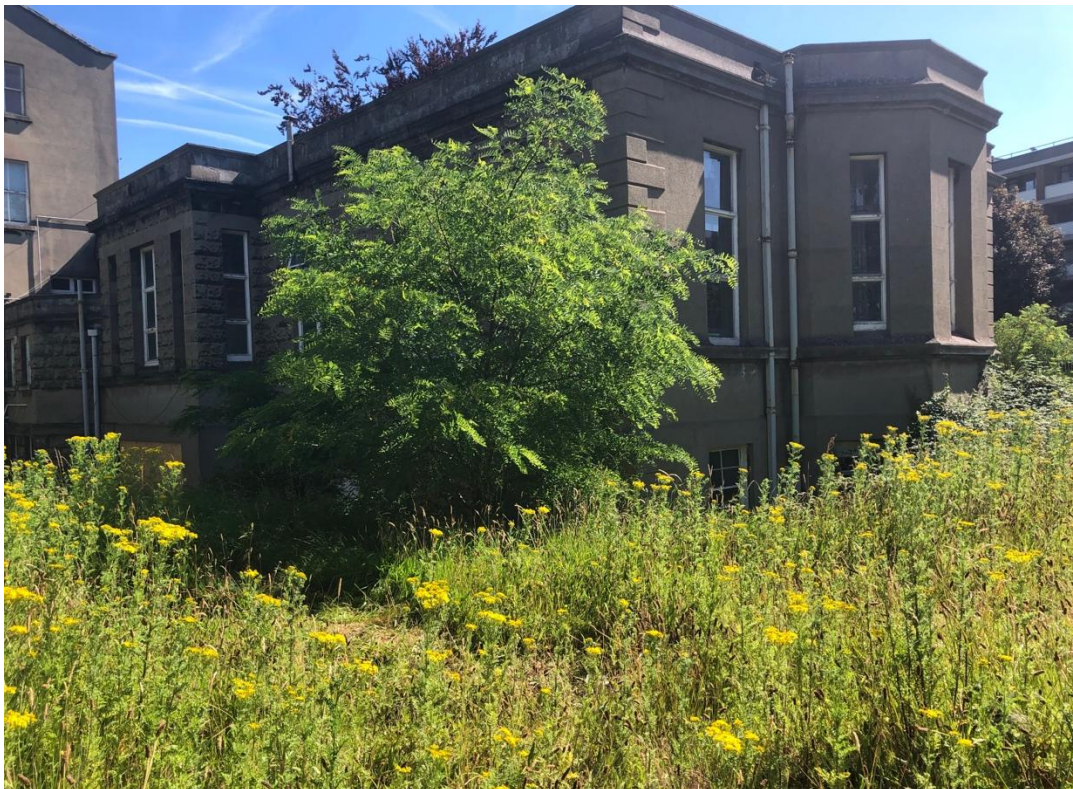
Plate 54: View of west elevation. Smooth ashlar finish to lower ground level with rock-faced finish to upper ground level.

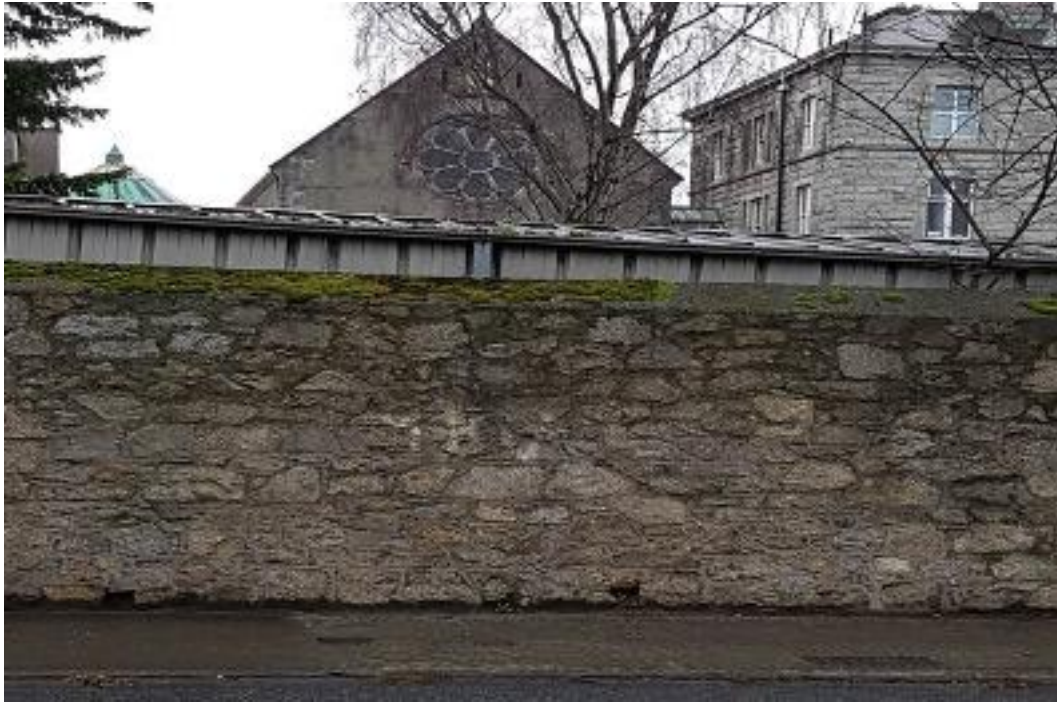
Plate 72: Perimeter rubble wall on Milltown Road with Chapel, stained glass window and Milltown Park House in background

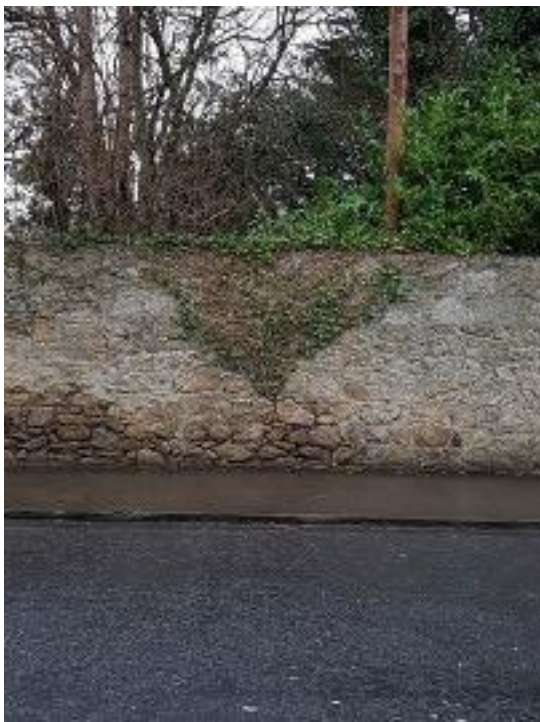
Plate 73: Section of rubble boundary wall on Milltown Road

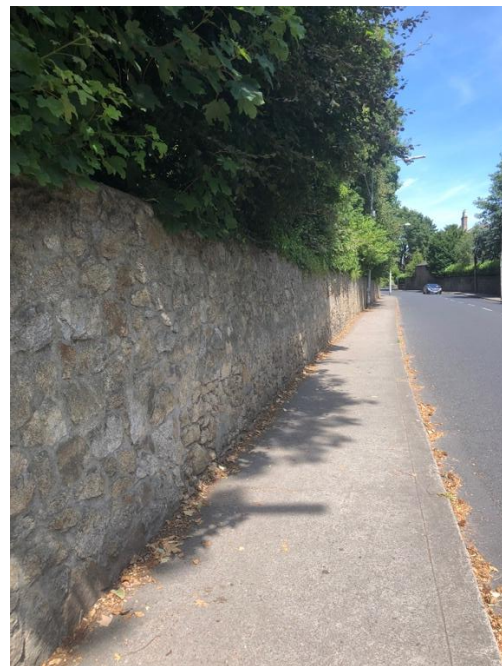
Plate 78: Curve of wall looking down Milltown Road, with pedestrian gate in centre

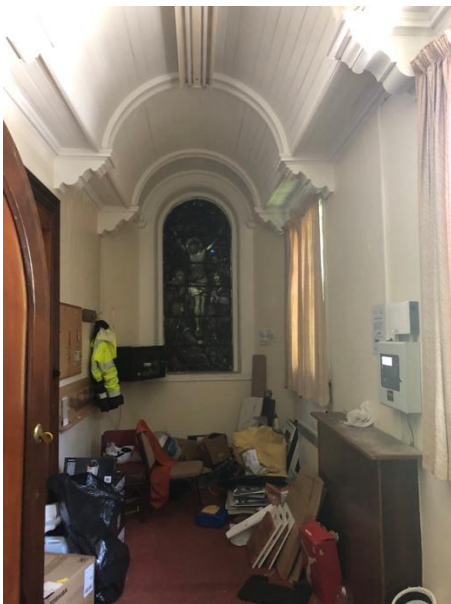
Plate 87: Vestibule/Holy Rosary Chapel, due north towards the apse and stained glass window

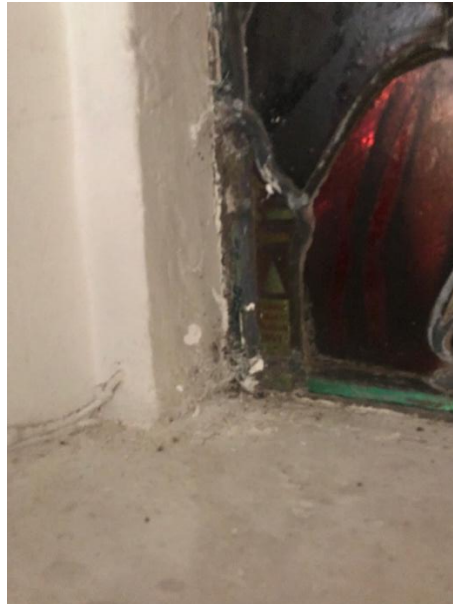
Plate 88: Stained glass signed CLARKE FREDK. ST DUBLIN 1897

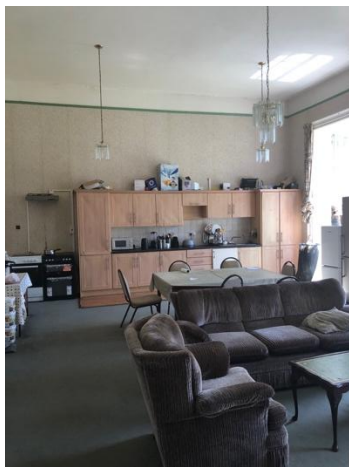
Plate 95: Large room within the former Orangery to the south with full height ceiling, missing fireplace, and more recently in use as kitchen/diner

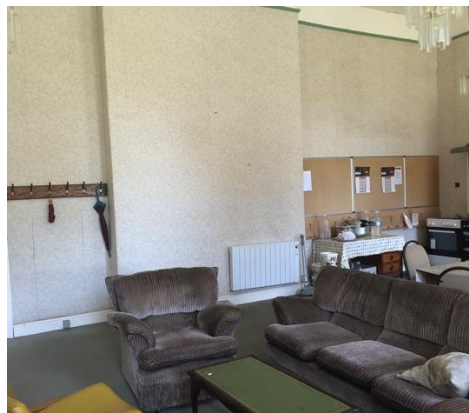
Plate 96: Historical features such as decorative plasterwork and fireplace removed.

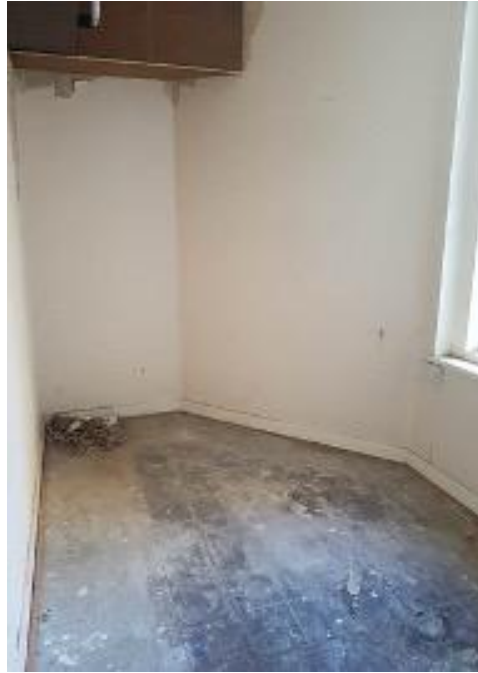
Plate 138: Small room with partitioned wall showing signs of water damage

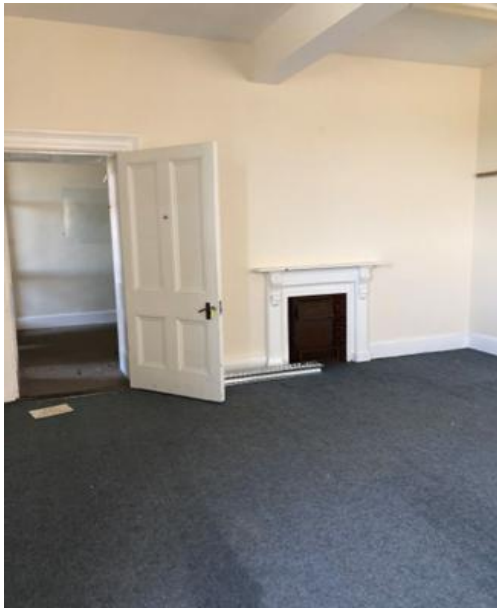
Plate 139: Lecture room within rear extension block at 1st floor level

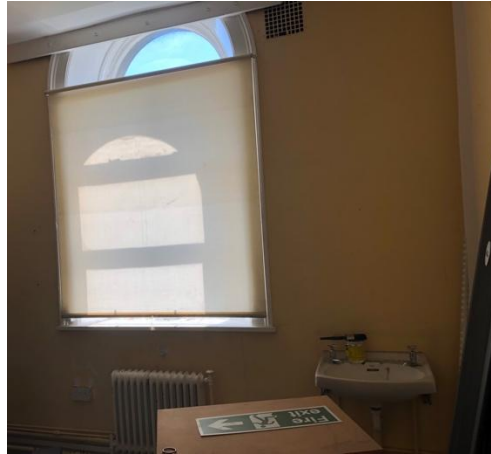
Plate 158: A typical dormitory with replacement arched window

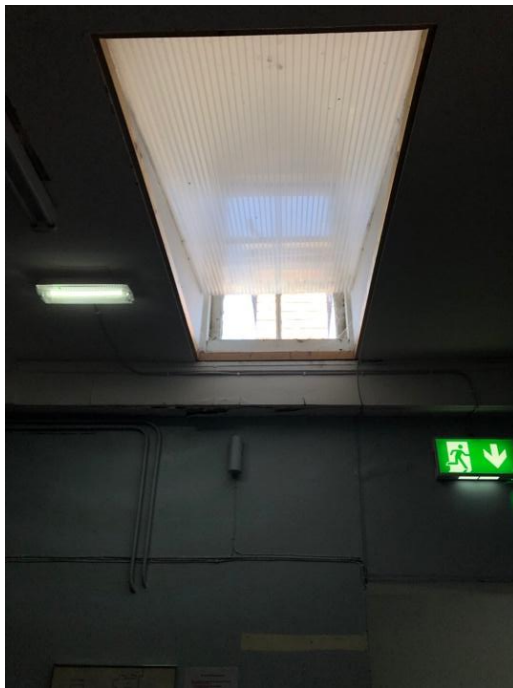
Plate 159: Roof-light at high level at rear of MPH

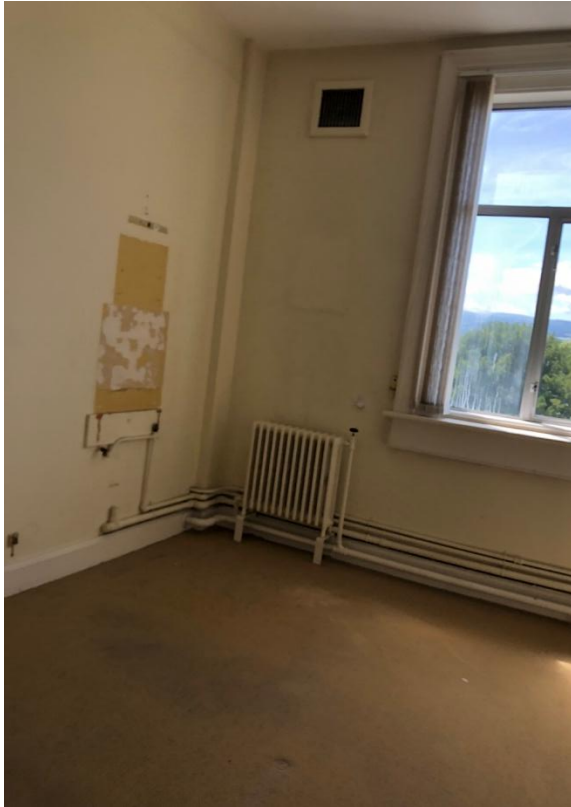
Plate 174: 2nd floor level typical study room to front (east) on first floor with signs of water damage

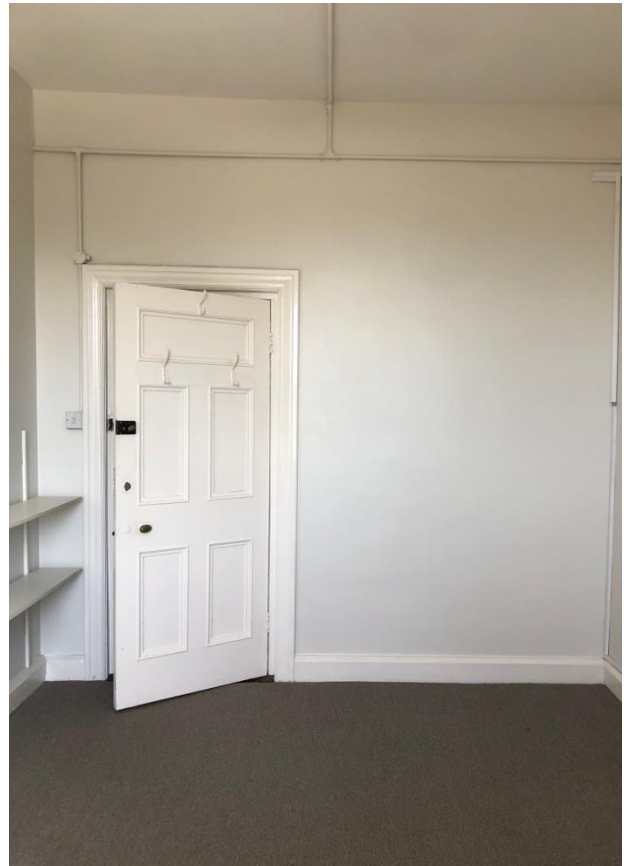
Plate 175: Same level rear room

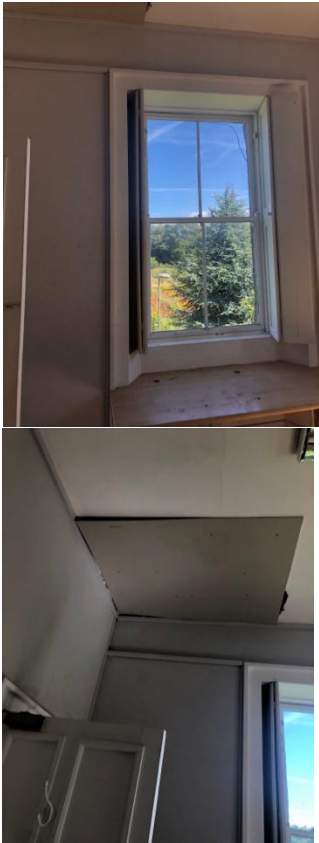
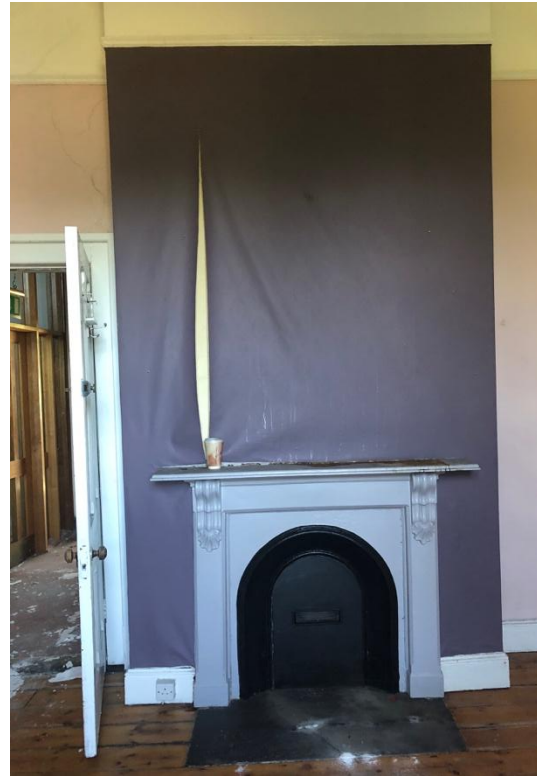
Plate 190: Typical entrance level accommodation with corbelled chimneypiece and original door, sashes and window boxes. Replacement window frames to northern elevation.

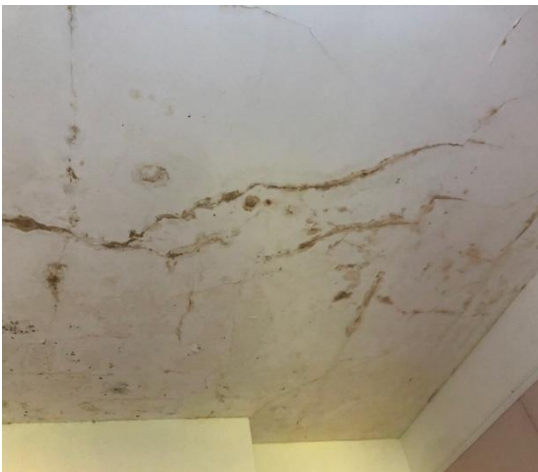
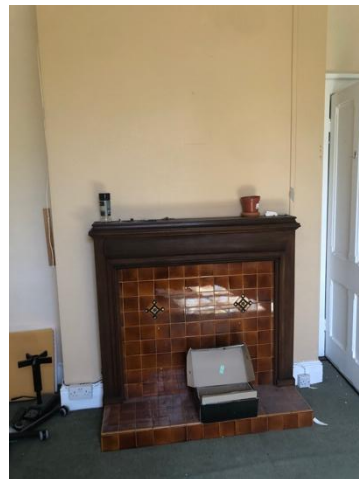
Plate 192: Evidence of water damage to ceiling fabric.

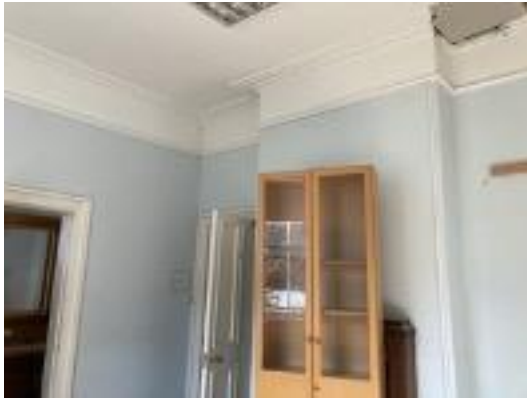
Plate 194: Stepped cornice and picture rail in ground floor accommodation.

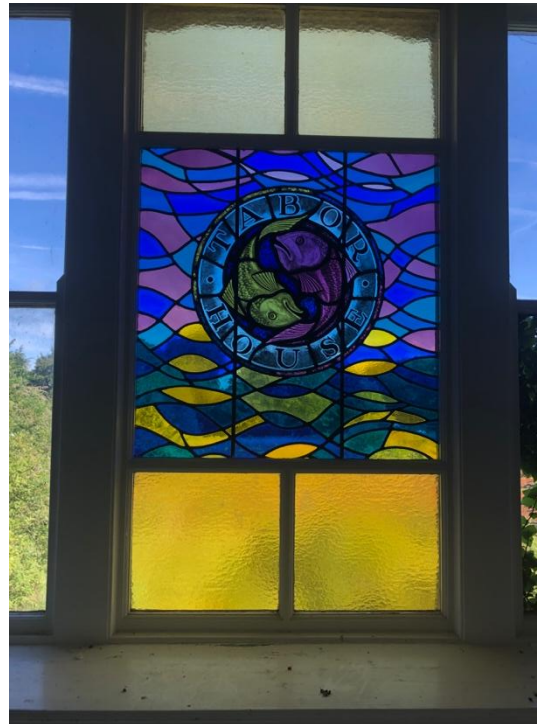
Plate 199: 20th Century stained glass window to north east end of entrance level corridor

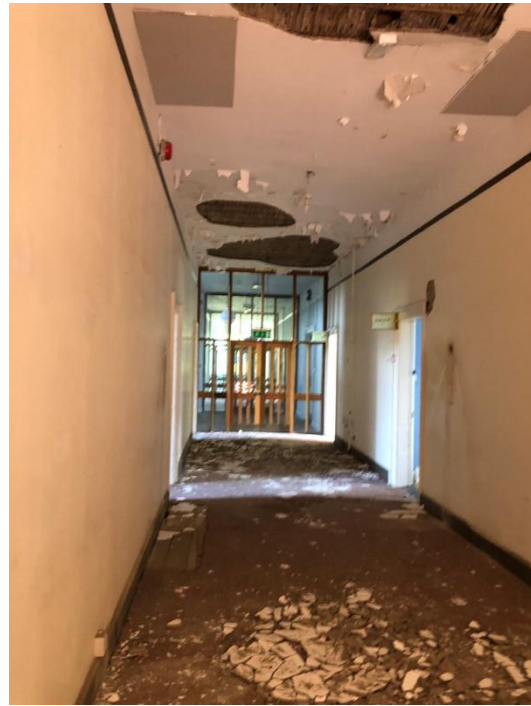
Plate 203: Entrance level corridor with later cross-corridor fire screens. Collapsed ceiling fabric due to water ingress in view.

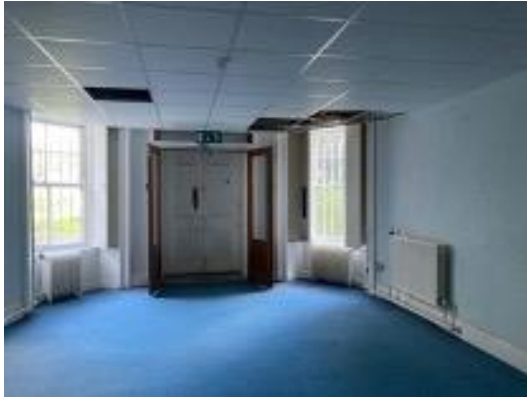
Plate 234: Lower ground floor entry to rear (north) elevation within rounded bay. Later suspended ceiling.

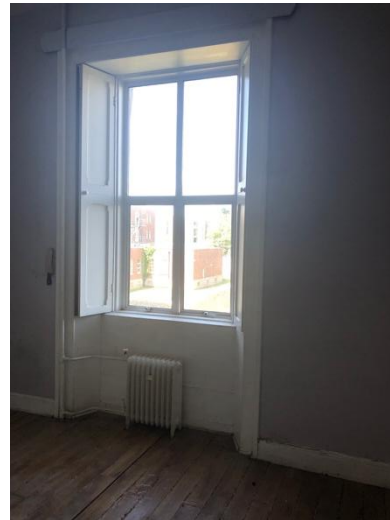
Plate 251: Original window boxes with contemporary uPVC window frame.

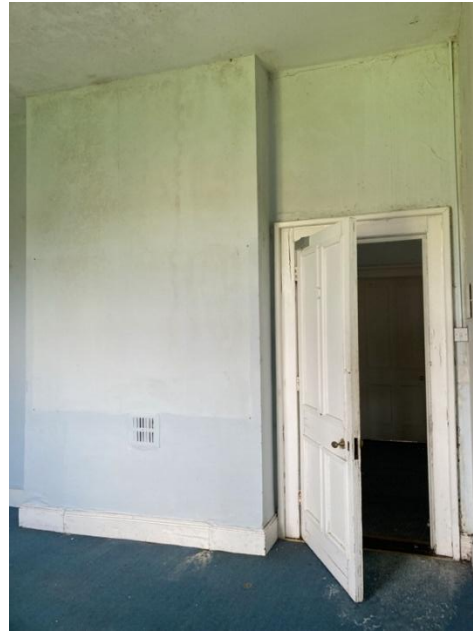
Plate 263: No chimneypiece. Original joinery. Staining of ceiling suggestive of water ingress.

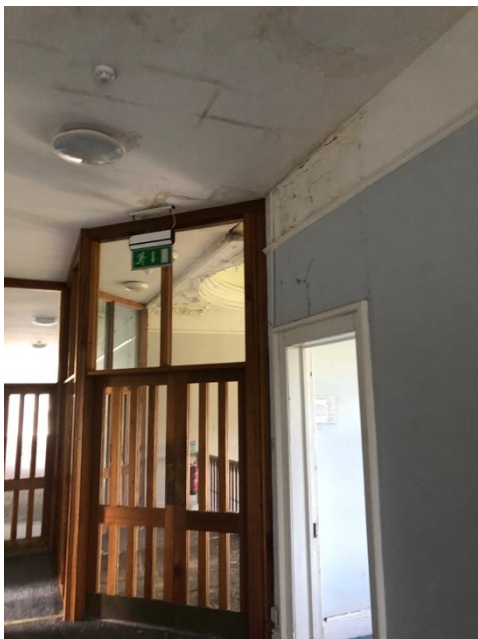
Plate 264: Second floor corridor with later screen doors to central stair and across corridor. Bedroom doors are panelled with moulded architraves.

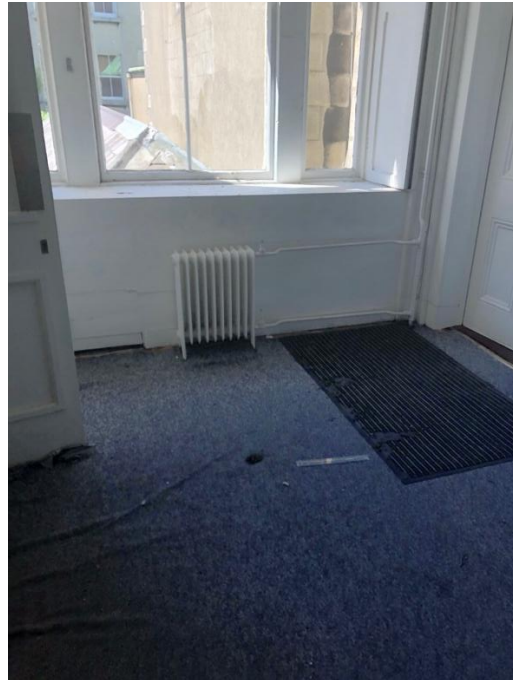
Plate 267: Damage to ceiling and wall fabric due to water ingress.

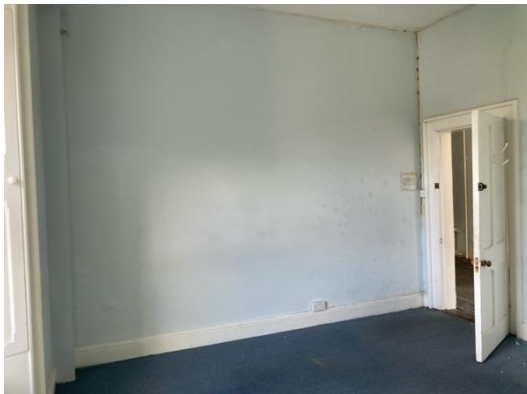
Plate 268: Typical upper floor accommodation. Original four paneled door and architrave.

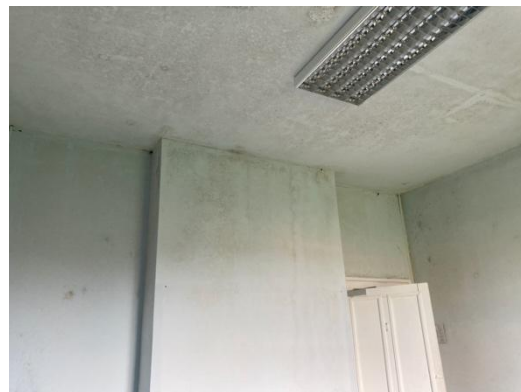
Plate 273: Mould growth evident on wall and ceiling surfaces.

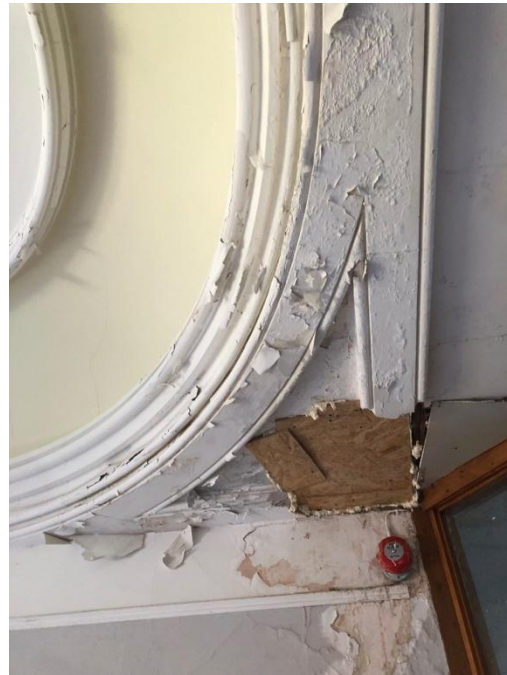
Plate 192: Flaking paint and staining of ceiling due to water ingress.

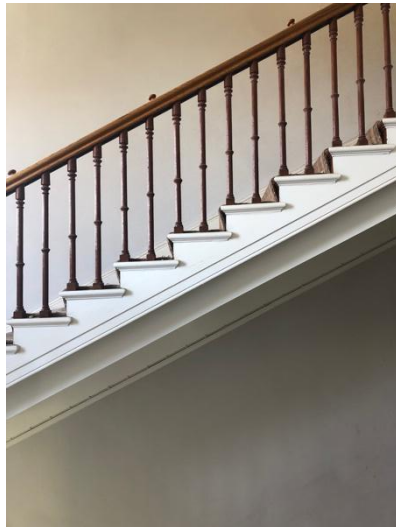
Plate 286: Detail of oak handrail

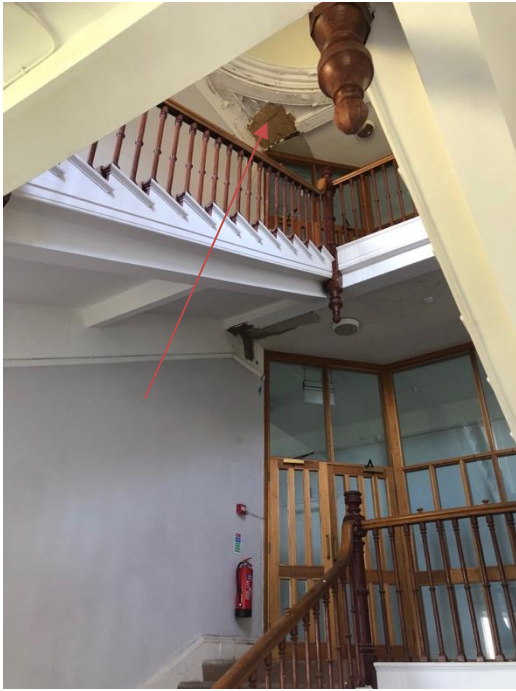
Plate 191: Damage to ceiling above main stairwell.

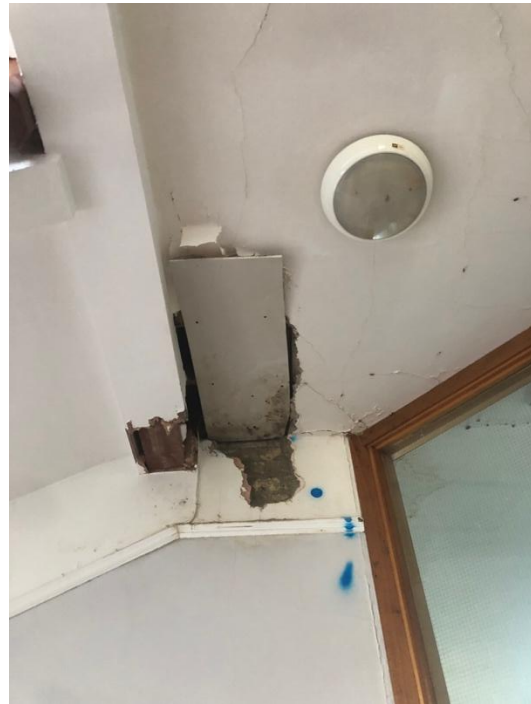
Plate 192: Roof breach in second floor ceiling with roof space exposed.

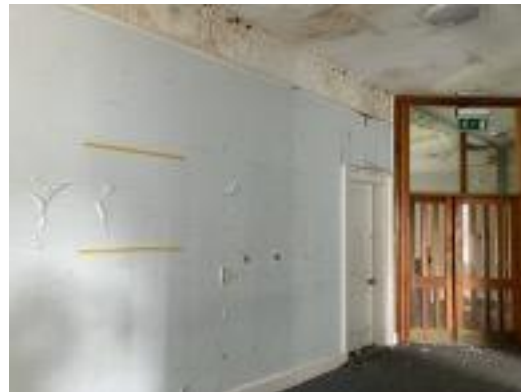
Plate 289: Central spine corridor with water damage evident on ceiling and top of walls.

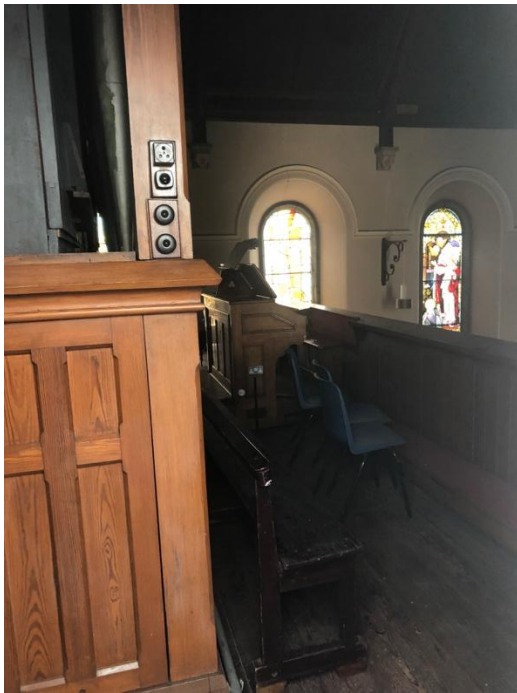
Plate 303: Gallery, facing west, with organ to rear.

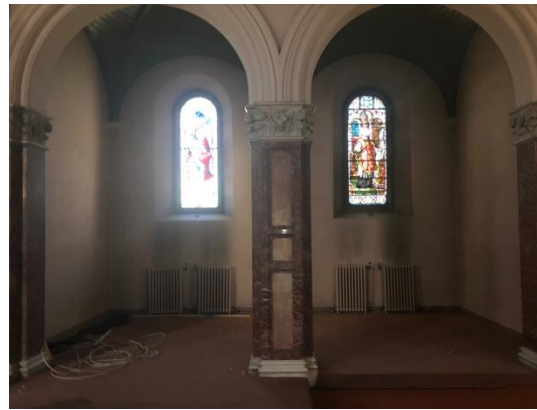
Plate 304: Side chapels with stained glass windows.

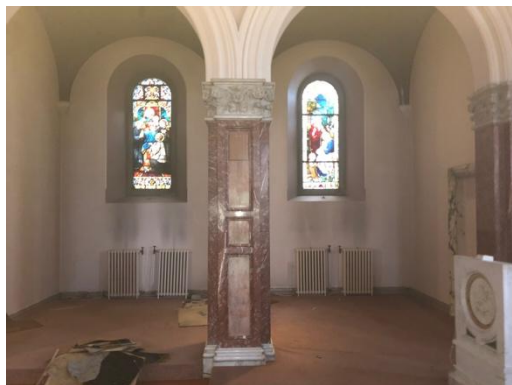
Plate 305: Opposing view, side chapels.

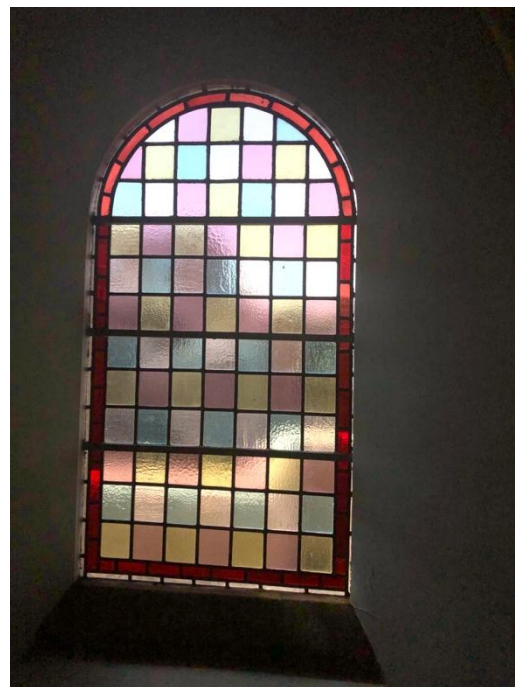
Plate 310: Round-headed window with stained glass. Curved plaster detail on reveal.

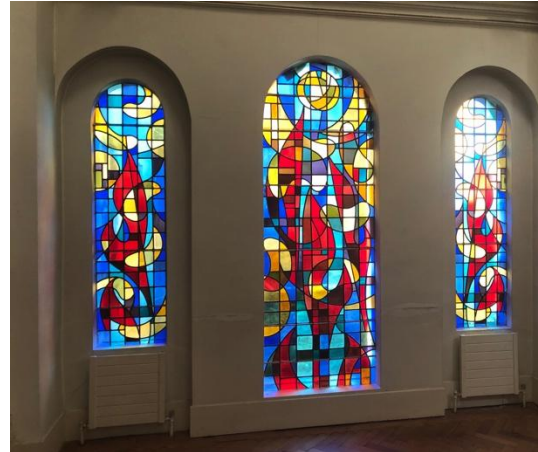
Plate 297: Modern, abstract, stained glass, c1980s appear to have replaced original stained glass

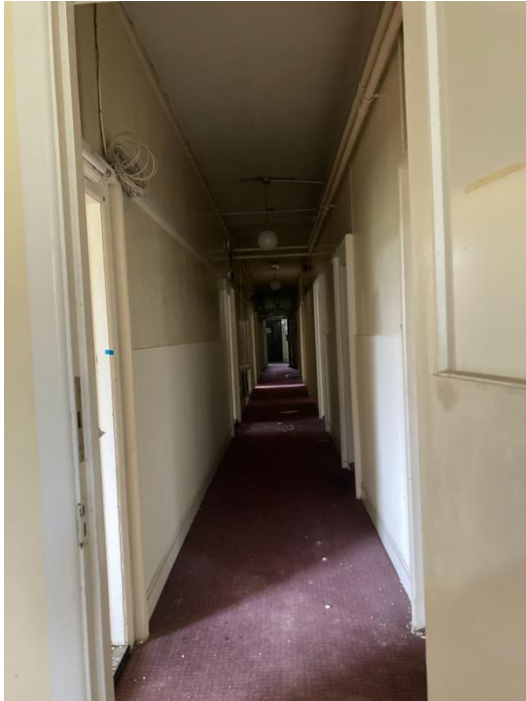
Plate 298: Corridor at lower ground floor level leading to dormitories and study rooms

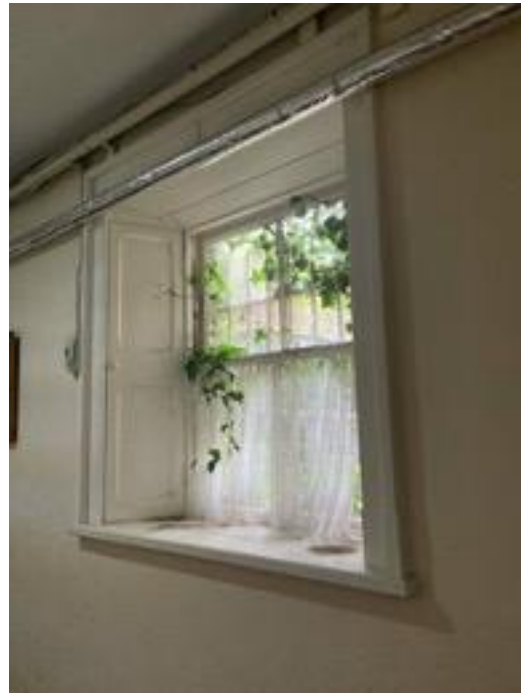
Plate 305: Detail of lower ground floor sash window and panelled shutters. Overgrown vegetation resulting in deterioration of fabric.

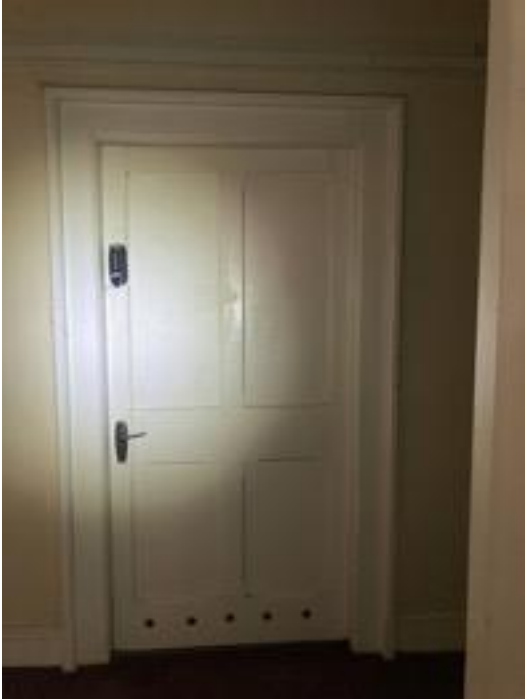
Plate 306: Typical panelled door and architrave at basement level.
