# **Appraisal Of Architectural Significance**

ATTACHED TO EIAR CHAPTER 7.0 ARCHITECTURAL HERITAGE

**MILLTOWN PARK, SANDFORD ROAD, DUBLIN 6**

July 2025

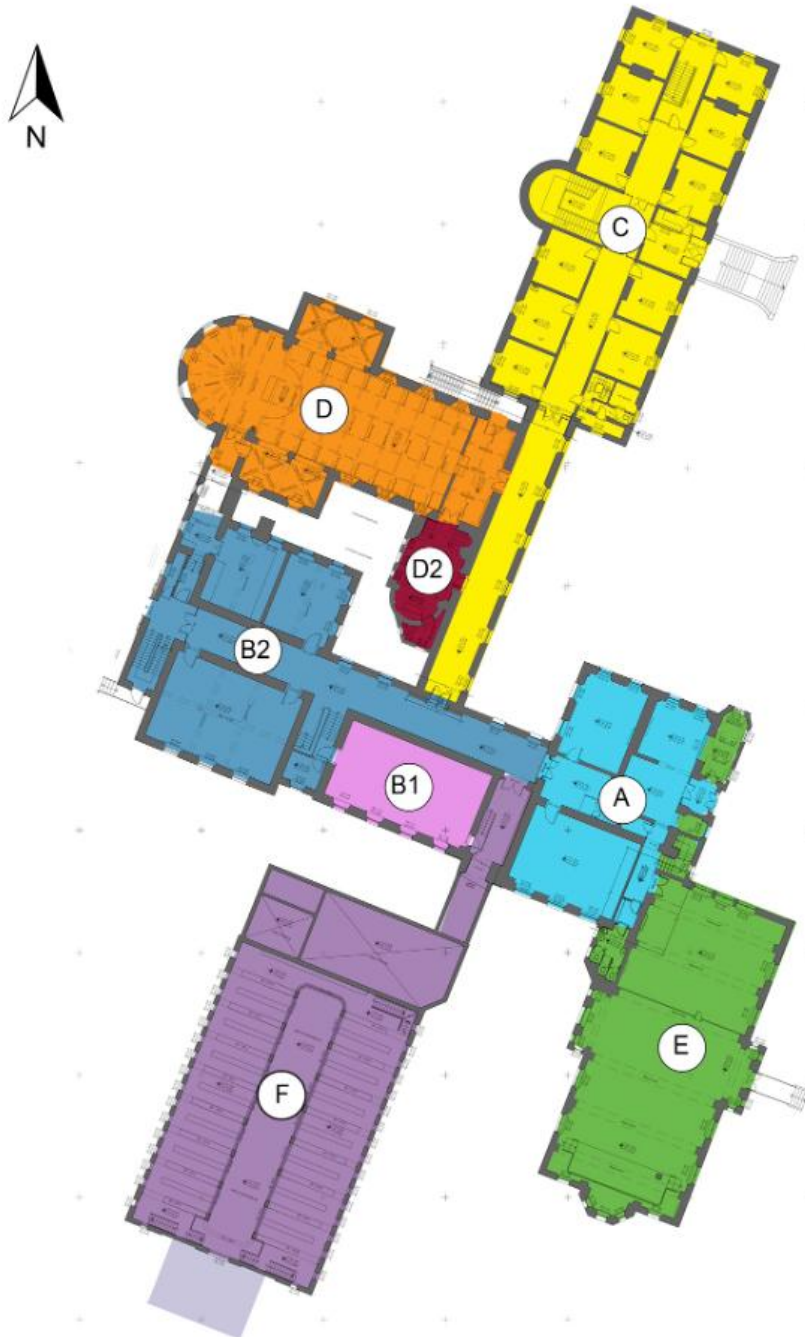
Fig. 1 Outline of building range- identifying each building element

- A Milltown Park House
- B Rear Extension
- C Tabor House
- D Chapel
- E Finlay Wing
- F Archive

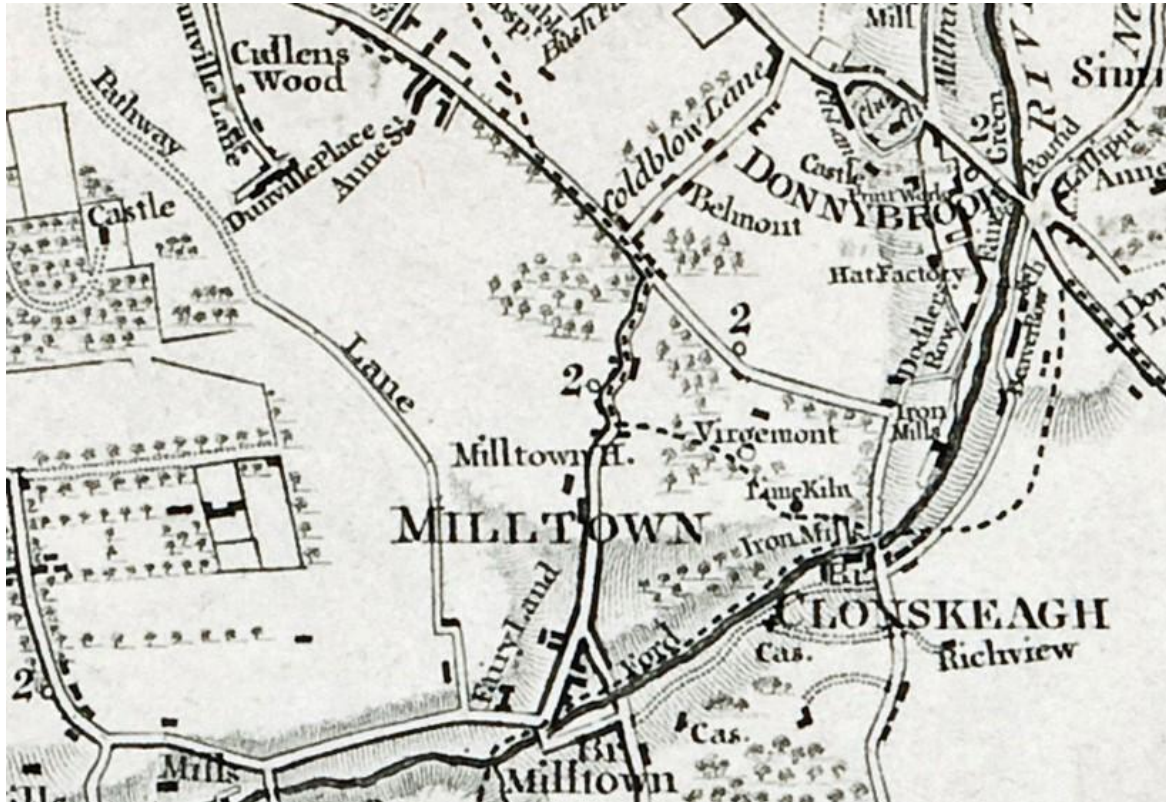
Fig. 3 Detail of John Taylor's map of 1816

The first map of County Dublin to be produced after Rocque's 1760 edition was published by John Taylor in 1816. This was a speculative venture and was not commissioned by the Dublin County Grand Jury. As the detail from this map that is reproduced above shows, there is no sign of a house at Milltown Park on Taylor's map. The scale is small, but the original farmhouse on the lands is still visible at the bend of the road just to the south of the number 2, while the dashed line opposite represents the line of Prospect Lane.

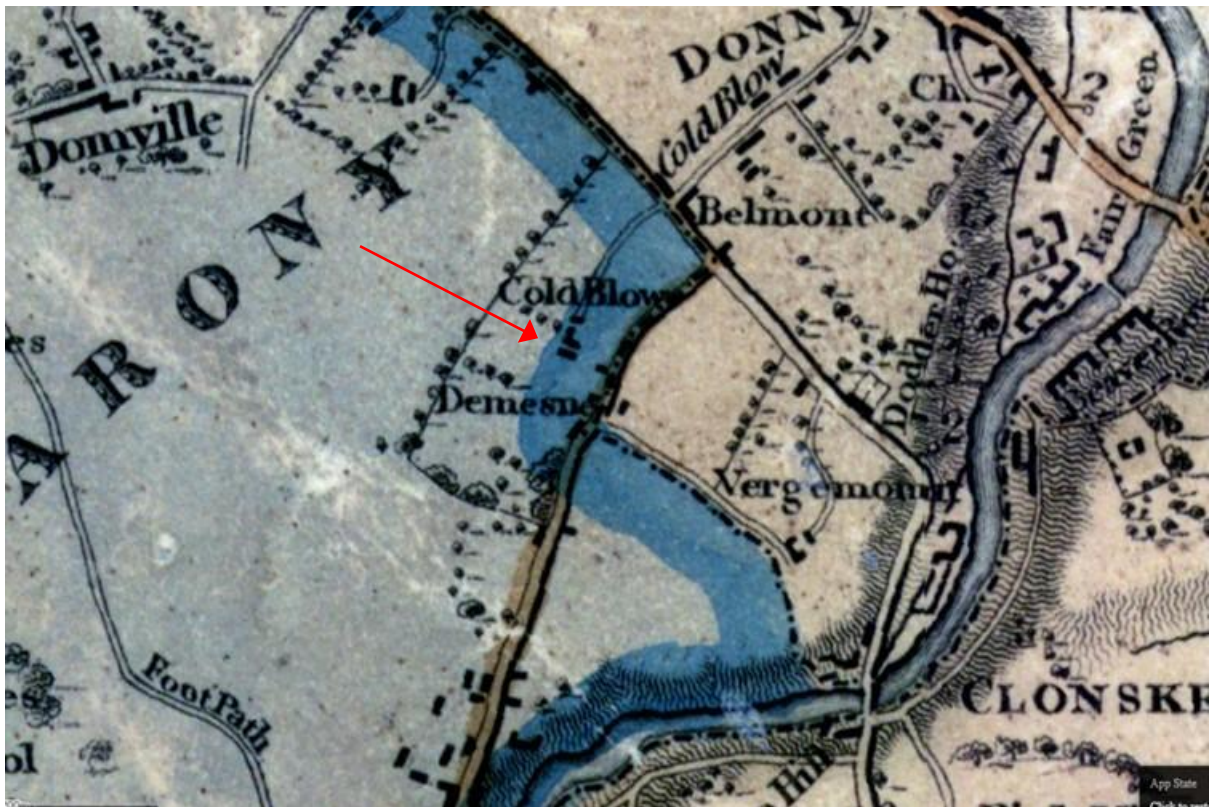
Fig. 4 Detail of William Duncan's map of 1821

While John Taylor was working on the surveys prior to the publication of his map the County Dublin Grand Jury commissioned another surveyor, William Duncan, to produce a map of the county. This map was finally published in 1821 and is in a similar style to Taylor's, though with a heavier use of hachuring to depict sloping ground. This map shows a driveway opening off Sandford Road opposite Belmont Avenue and leading southward to a house of some substance. The house is enclosed within a rectangular site and the property is labelled "Coldblow Demesne". Coldblow was the name for a small village on Sandford Road and the area in its vicinity; the village was later subsumed into the village of Ranelagh.

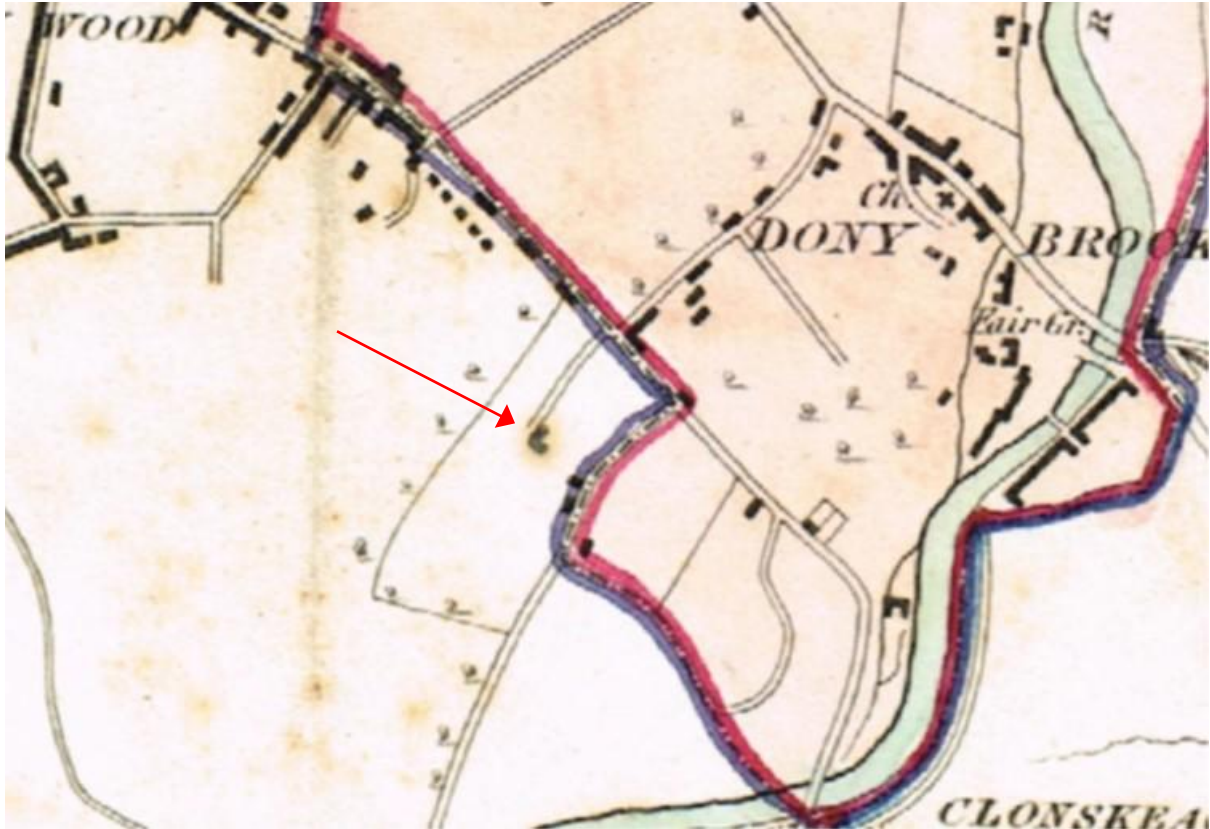
Fig. 5 Detail of Boundary Commission map showing the house

A similar layout of the driveway, house and rectangular boundary was subsequently depicted on a map prepared by the Boundary Commission in 1832 and reproduced overleaf.

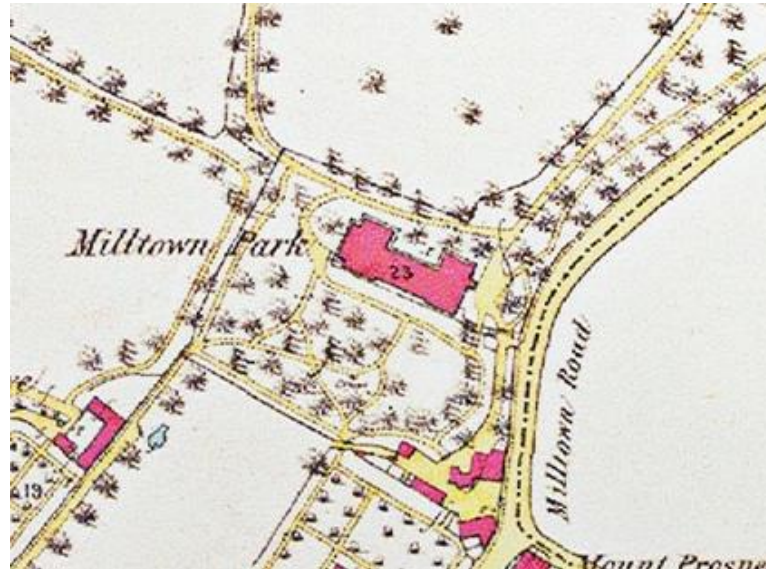
Fig. 8 Detail of Ordnance Survey map, sheet 22-4, 1864

Following the departure of the Hamiltons Milltown Park was acquired for the Society of Jesus in 1858 as part of a plan to establish a retreat house, novitiate and school. This required the enlargement of the premises and soon after acquiring the property the Society built a substantial extension to the rear of the house, while an additional floor was added to Milltown Park. This new structure is clearly seen on the Ordnance Survey's larger scale map, published at the scale of 1:2500 in 1864 and reproduced below. The original house is seen at the right-hand end of the enlarged building, with its projecting porch on the eastern side. Multiple internal modifications appear to date from that time with a generation of new openings to connect the original structure with its rear extension. This substantial addition brought the ratable value of the buildings up from £81 to £150.

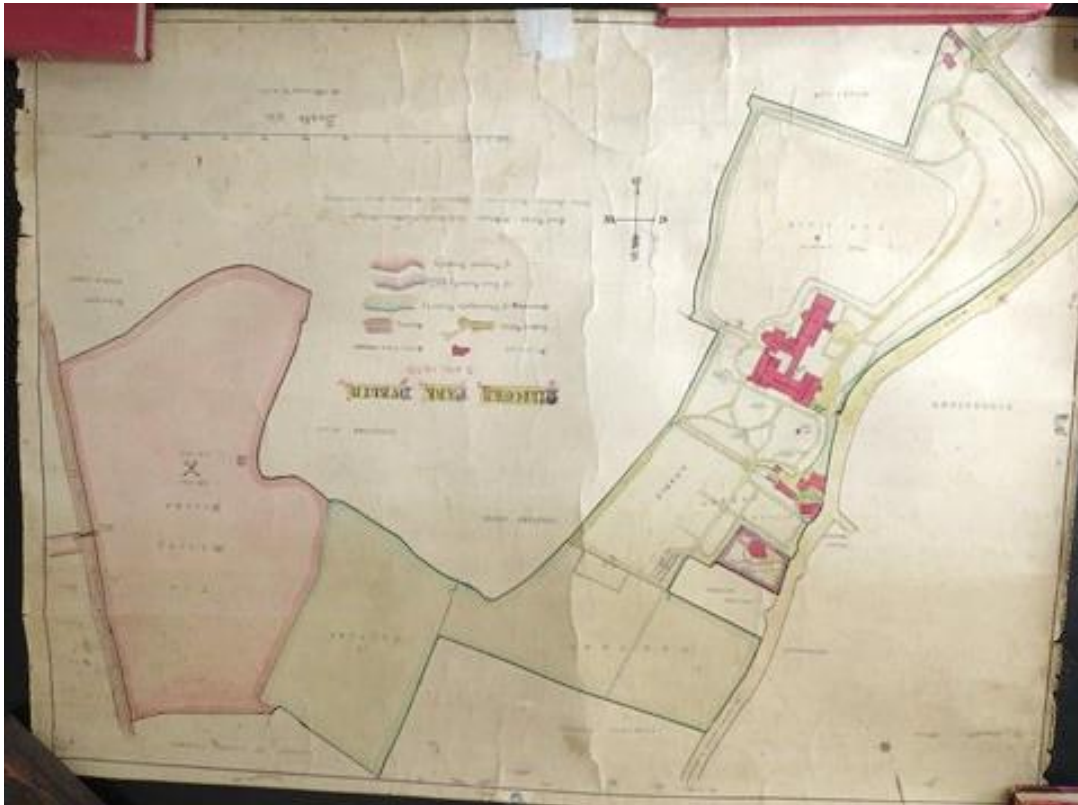
Fig. 10 Photograph of a deed map from 1903 showing the boundary of Theologate property at that time. Note: map is reproduced upside down to remain consistent with the other maps for comparison purposes.

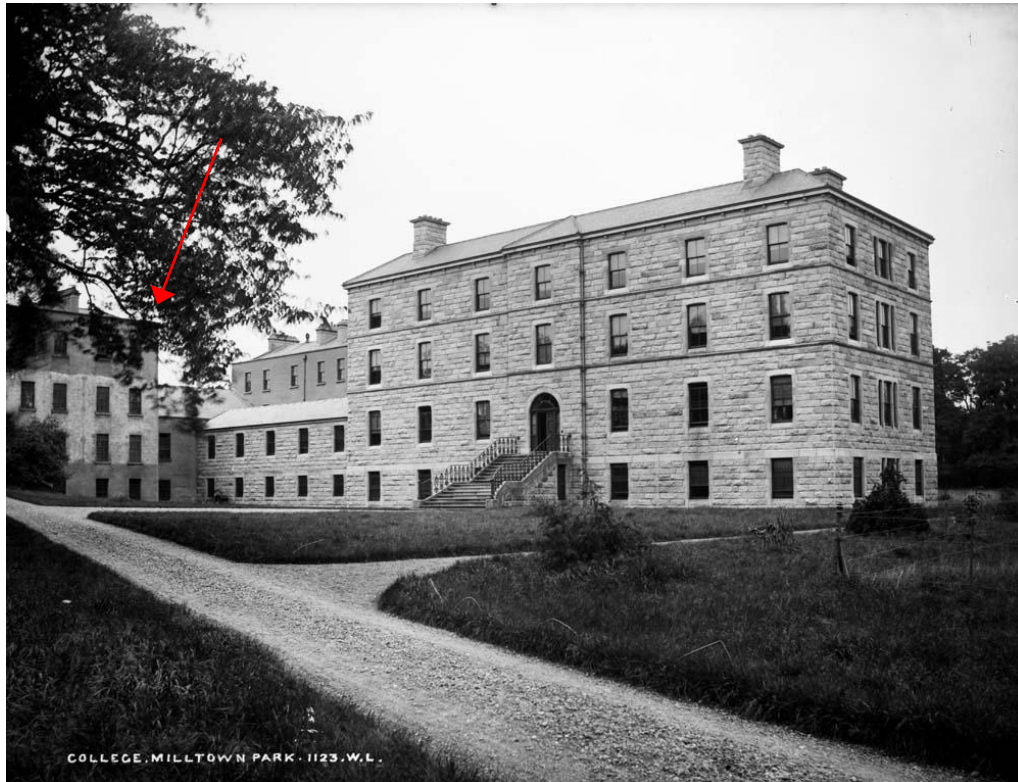
Fig. 12 *Milltown Park, (Tabor House photographed shortly after its construction)*

The photograph above, taken by Robert French, probably soon after Tabor House was built, shows the two-storey link to the earlier buildings. On the left-hand side the northern end of Milltown Park is seen and the difference in colour of the top floor indicates the addition of that floor some years earlier. This photograph also confirms that the upper floors of the central section of the rear extension of MPH was not yet constructed by this time.

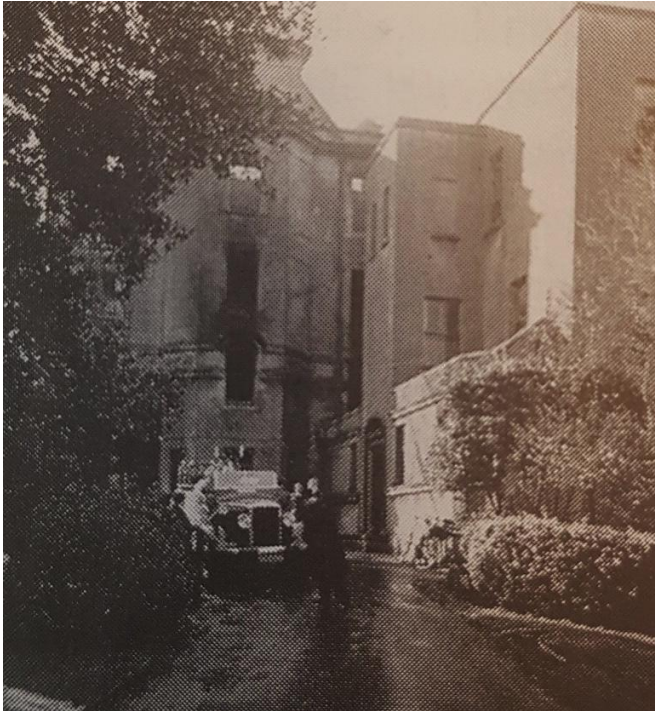
Fig. 16 *The fire damaged exterior of the Finlay Wing, indicating its original height of three storey over basement with pitched roof over.*

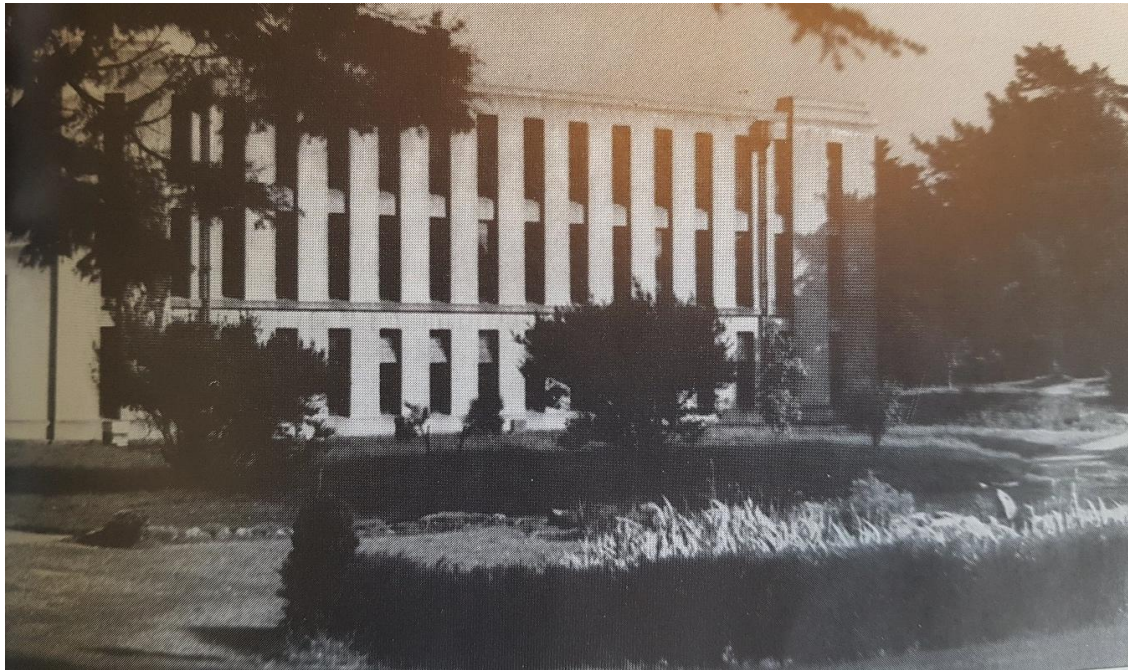
Fig. 17 *The exterior of the Milltown Archive, taken shortly after its opening in 1940*

The mass concrete Archive was constructed in 1938 reflecting the scarcity of traditional building masonry of the era. Development continued on the site in the 1950s acquisition of the two houses to the west of Milltown Park at Sandford Hill and Sandford Grove, and with it the construction of a community house, connected with the existing buildings by way of a single-storey link. Gonzaga College was founded at Sandford during this period. The Community building range, together with Gonzaga College, are outside the present site and do not form part of this assessment.

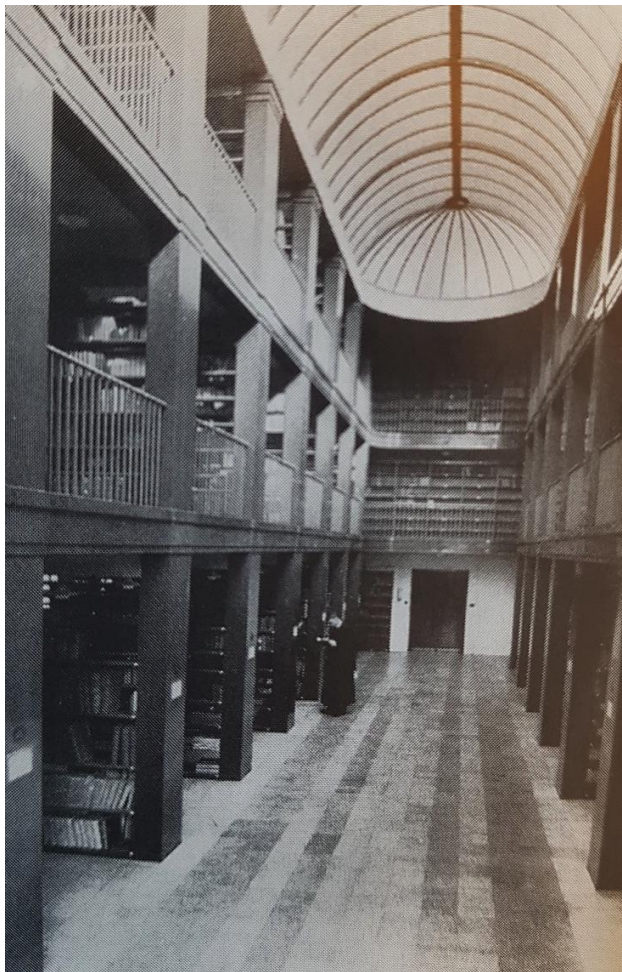
Fig. 18 *The interior of the Archive following its opening in 1940 showing central stacks. Whilst the building endures as designed and reflected in this image, the private religious Archive has been relocated to the Jesuit buildings in Leeson Street, leaving the archive building empty of all material.*

The building's interior reflects its function as an archive. A quadrangle generated by a pressed copper-clad structure encircling at three levels an apse ended lantern roof light, comprises book shelving aligned with the structure to create bays each having their own window. Guarding in steel uprights with polished oak handrail encloses the bow ended void.

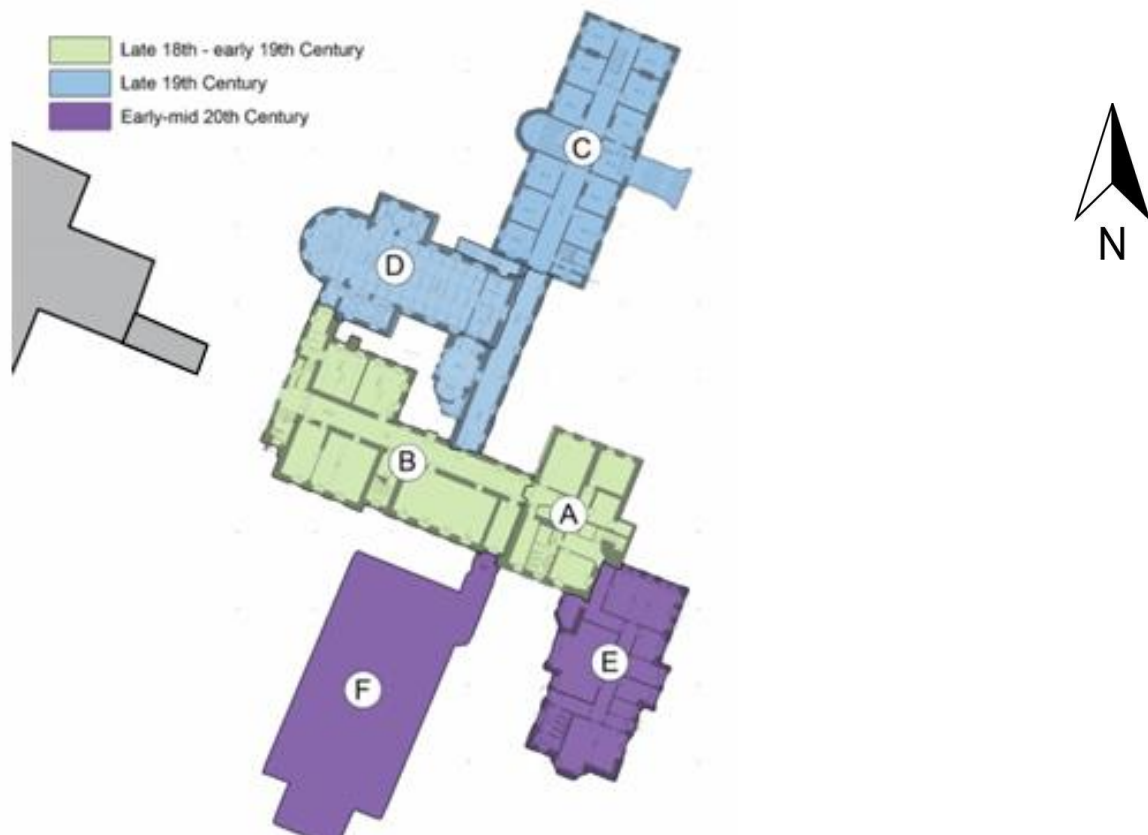
Figure 19 below depicts the general era of construction of each element of the existing building range.

Fig. 19 Approximate chronology of each building element cited in Fig. 2 above

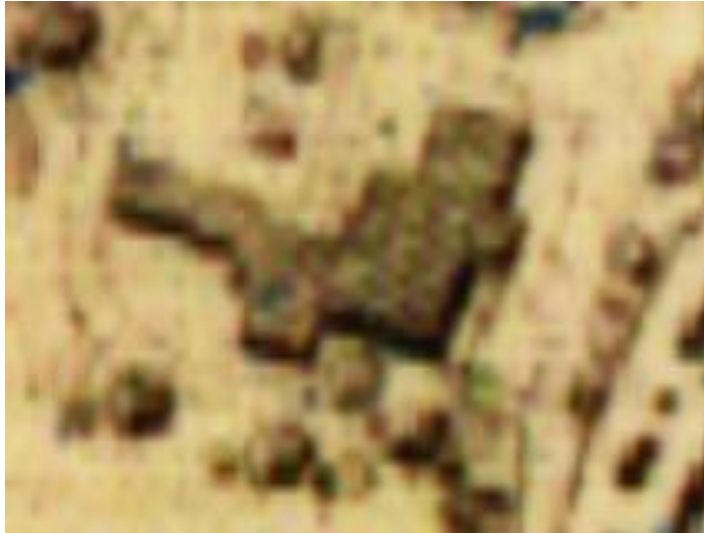
A range of possibly single storey outbuildings were constructed to the southwest of the house, accessed from the lower ground/ basement level, and appear to have addressed open gardens, with no hierarchical definition of yard enclosures as would be expected of a building of its genre. No trace survives of either the return or outbuildings, clearly demolished to accommodate development as a novitiate c1860.

Fig. 20 Extract from 1847 OS map, with mid-19<sup>th</sup> century form of the House and its ancillary structures evident.

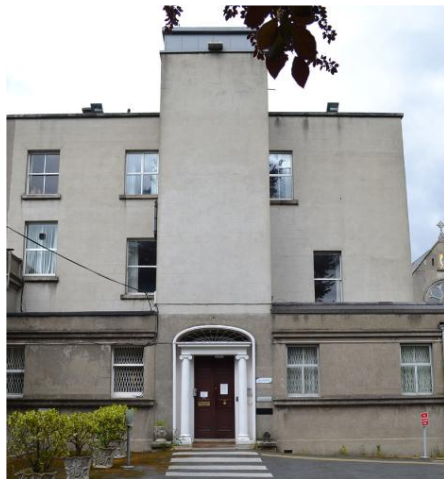
Fig. 21 Present day configuration of east (front) elevation of Milltown Park, with the vertically extended entrance lobby; vertical extension to south (denoted by higher level windows) and repositioning of first floor windows

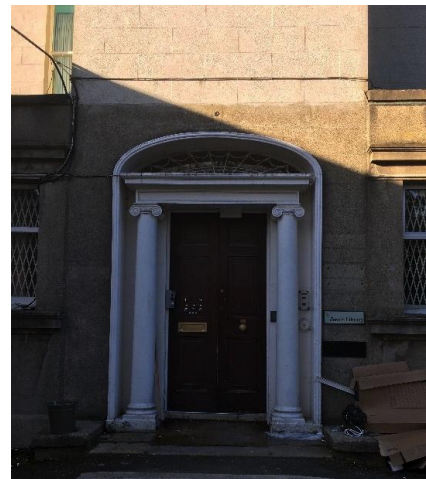
Fig. 22 Detail of the surviving entrance door and fanlight within a much-altered context.

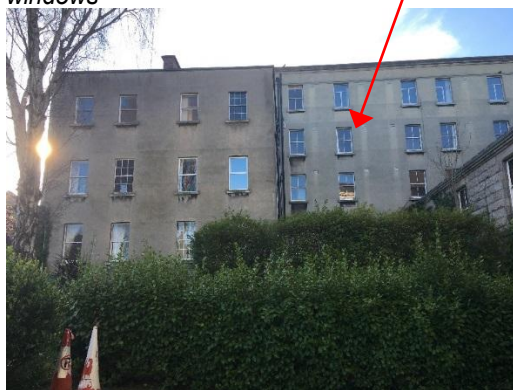
Fig. 23 North elevation of Milltown Park, which was vertically extended in the late 19<sup>th</sup> century. The north elevation of its rear, higher, extension was constructed in the 20<sup>th</sup> century.

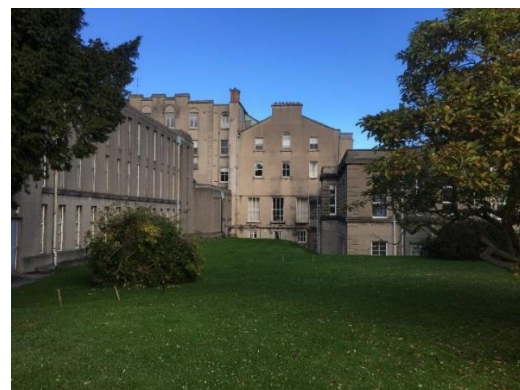
Fig. 24 Southern elevation, comprising an extension, with its expressed gable. Note the uncomfortable connection with its rear, later, extension, at a storey higher.

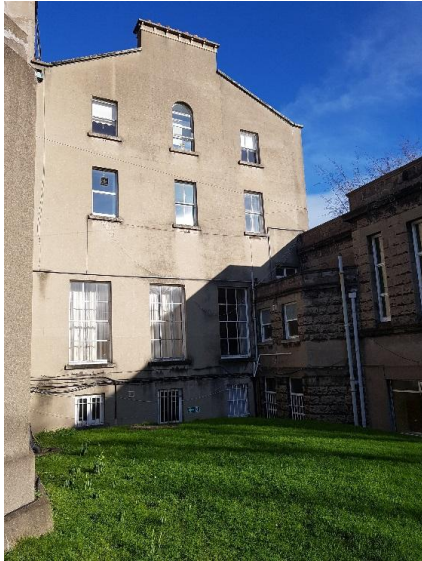
Fig. 25 Southern elevation, comprising an extension, with its expressed gable in context with the Finlay Wing and Archive (corner visible). Lower windows are early in origin, with the 6/6 windows attached to a former orangerie, which was vertically extended in the 20<sup>th</sup> century.

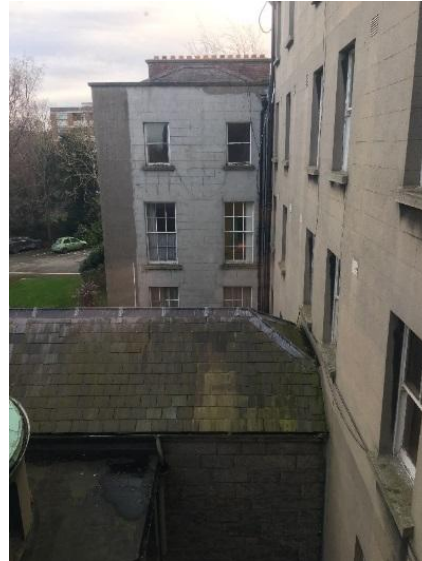
Fig. 26 Part of rear (west) elevation, with uppermost level added, and in context with its higher rear extension.

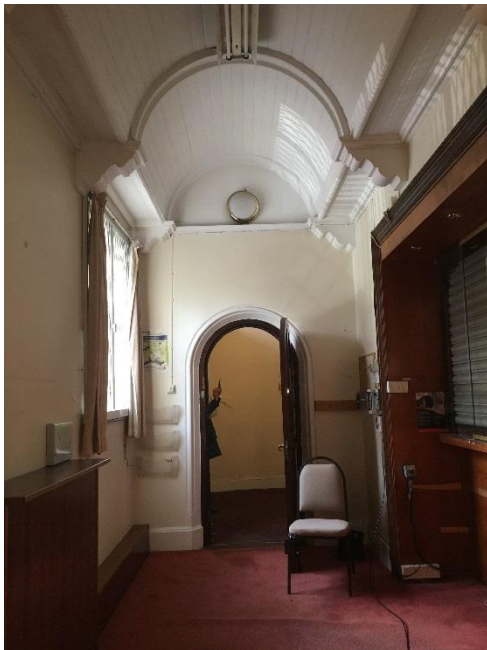
The entrance vestibule was extended vertically to accommodate bathrooms at upper levels, accessed off the main (modified) stair hall. It was also extended to the north to provide an entrance vestibule with decorative expressed internal ceiling structure and stained glass window. An extension to the south served to connect the house with the Finlay Wing.

Fig. 27 Entrance vestibule, towards the entrance porch

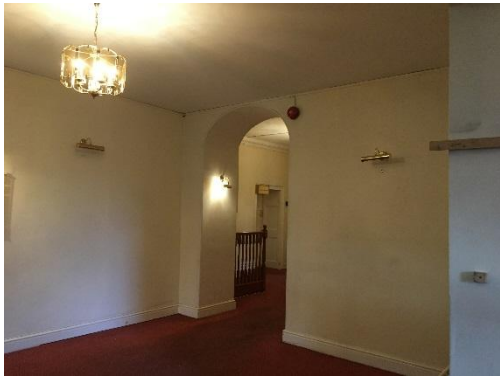
The most significant alteration internally is the removal of the central staircase and infilling of what would have originally comprised a grand double height entrance hall.

Fig. 29 *Infilled entrance hall at entry level with modest access to rear inner hall, leading to the late 19<sup>th</sup> century extension block. Stair visible through the arch accessing upper floors.*

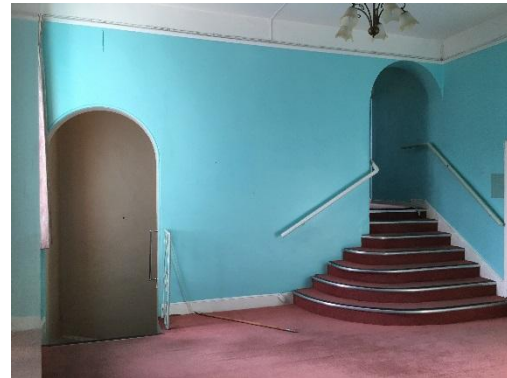
Fig. 30 *First floor level infilled entrance hall with later wall painted blue. Curved stair leads to vertical extension wing above a former orangerie.*

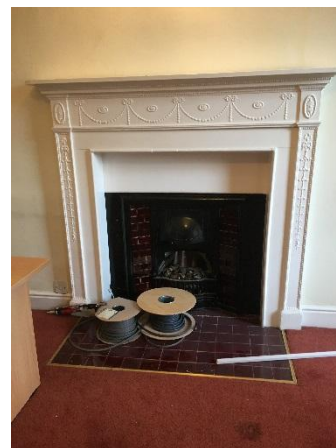
Fig. 32 *Early chimney piece with later tiled inset and hearth, in same room.*

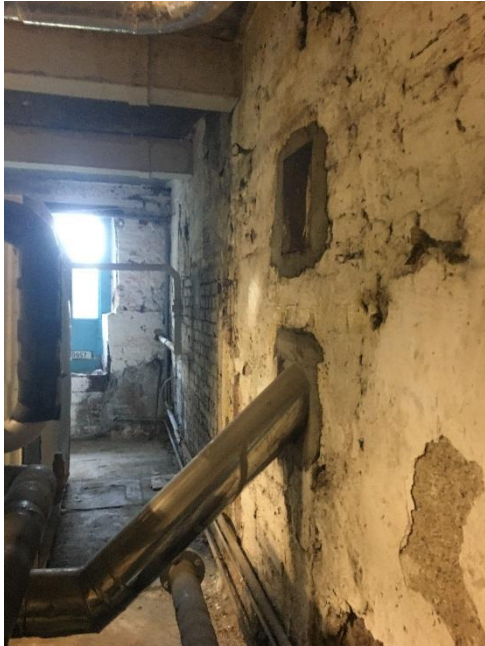
Original fabric is most evident at basement level, where an early kitchen survives to the northwest, having original flag flooring and surviving sections of original walls.

Fig. 33 Former kitchen to northwest at basement level, with original masonry and floor flags evident. Note concrete downstands for concrete floor plate supporting entrance level above.

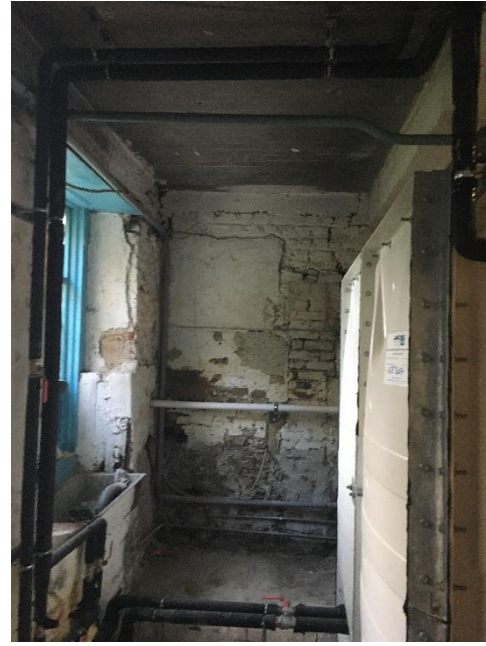
Fig. 34 View east in same room

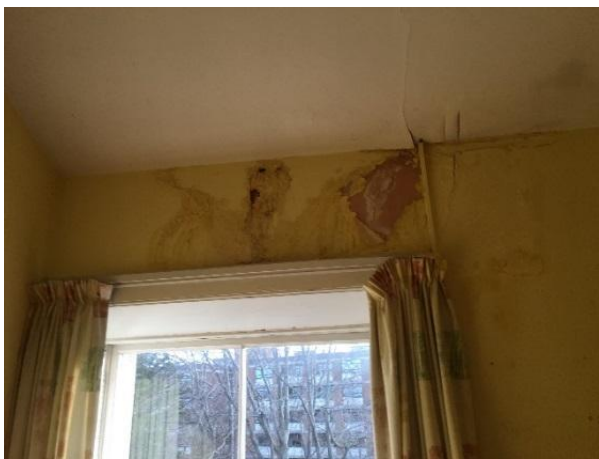
The property is in poor condition, with extensive roof breaches causing decay internally, extending from 2<sup>nd</sup> floor level down through the building.

Fig. 35 Example of decay due to water ingress from breaches in roof coverings, at 2<sup>nd</sup> floor (later intervention) level

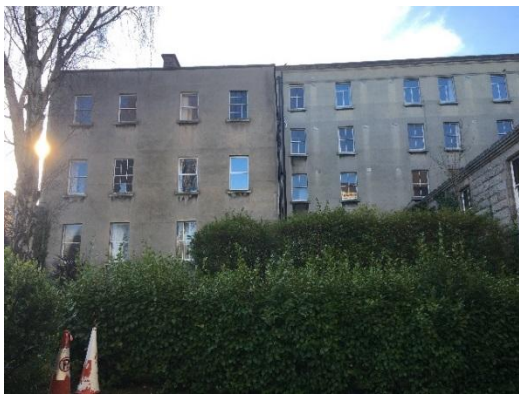
Fig. 36 *The extension's later northern infilled section in context with the north elevation of the main house, with the two storey Chapel link to the RHS of the image.*

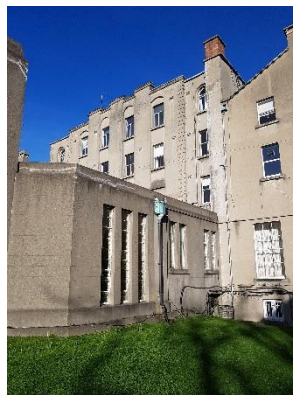
Fig. 37 *The later southern central extension in context with the Archive.*

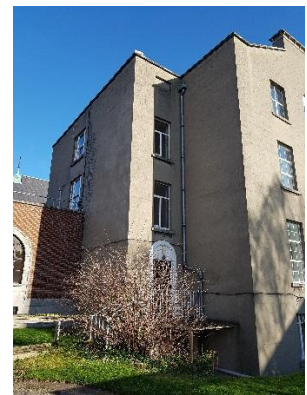
The orangerie was vertically extended in the late 19<sup>th</sup> century, with eastern windows blocked up in the early 20<sup>th</sup> century provision of the Finlay Wing. Its expressed gable treatment matches an opposing identical composition culminating the west end of the residential extension block.

Fig. 38 *The original extension rear wing to west, matching the southern (extended) gable of Milltown Park House*

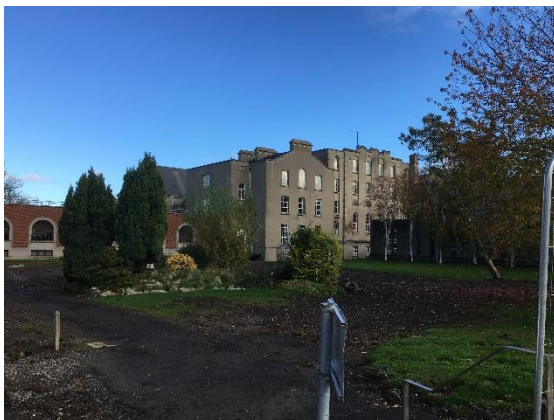
Fig. 39 *Southwest view of the original extension, culminated in an expressed H form gable building corresponding with an addition to the main house, (F.21 above). The taller central section is a later addition.*

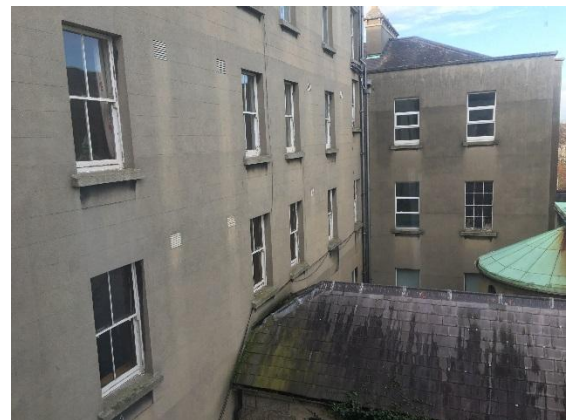
Fig. 40 *View of the (later) northern extension from a rear 1<sup>st</sup> floor window of Milltown Park house, towards the opposing (original) H form comprising a lower building, possibly intended to align with MPH.*

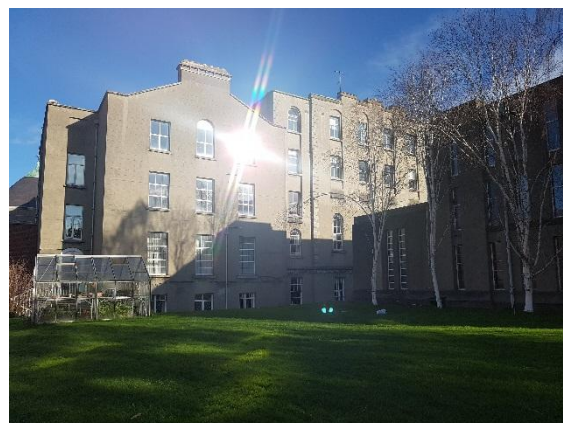
Fig. 42 View from west of expressed gable

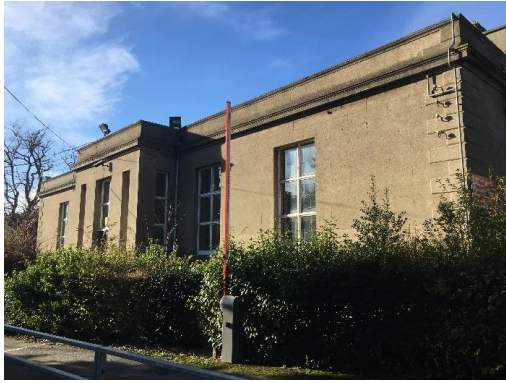
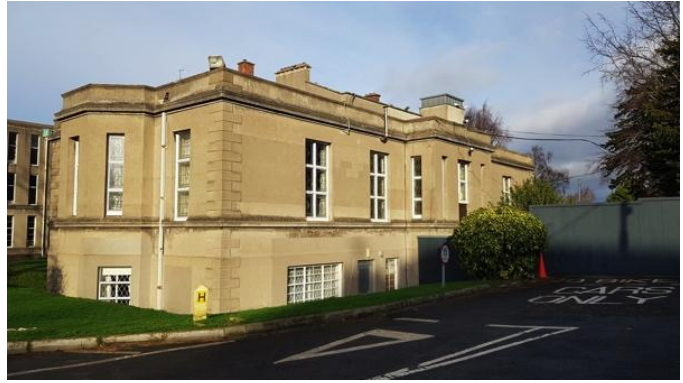
The external character of the Finlay Wing as existing comprises its reconstruction following a fire in 1949, where a four storey over basement building was altered as a single volume building. Externally, the building is sparse and representative of budget-driven economy of mid-20<sup>th</sup> century development.

Fig. 43 View of east elevation

Fig. 44 View of east elevation

Element	Composition	Condition	Comment
East elevation	The east (front) elevation comprises a 5-bay composition with projecting central porch; flat roofed with expressed parapet cornice and quoins in arised cement render and six panelled metal	Generally good.	The modest composition reflects a paucity of budget at the time of reconstruction, with materials used to good effect in the articulation of

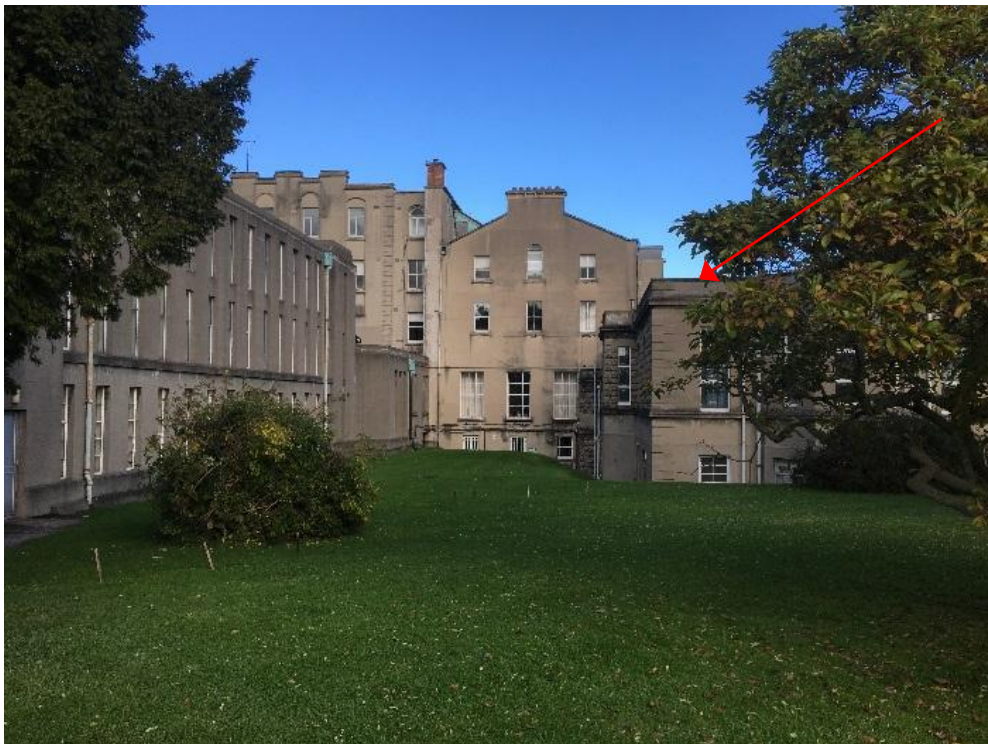
Fig. 45 View of south elevation (behind tree) as demarked by arrow

casements.		windows with leaded lighta and stained panels.
<b>West elevation</b>	The west elevation corresponds with the east, without the projecting porch.	Generally good.	As above
<b>South elevation</b>	The southern elevation has the best setting and supports a central projecting bay corresponding with that on the east elevation.	Generally good.	The parkland setting enhances this elevation.
<b>North elevation</b>	The northern elevation is partially visible to the fore of Milltown Park House. It boasts a leaded tryptic window composition, likely salvaged from the original building in its reconstruction.	Generally good.	This elevation is compromised by its crude juxtaposition with Milltown Park House.
<b>Basement level</b>	The basement is simply arranged with cellular accommodation either side of a central corridor.	It has suffered extensive rising damp, with evidence of flooding via a door to the east.	The basement is unremarkable, with its most significant feature comprising metal framed windows and carefully expressed services.

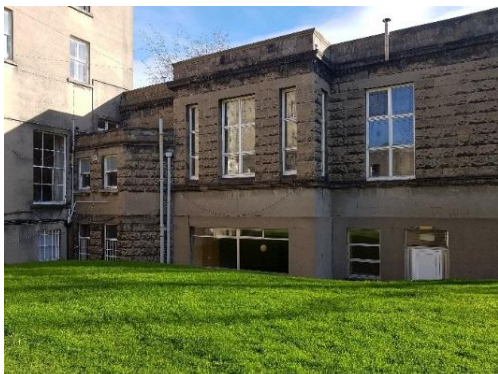
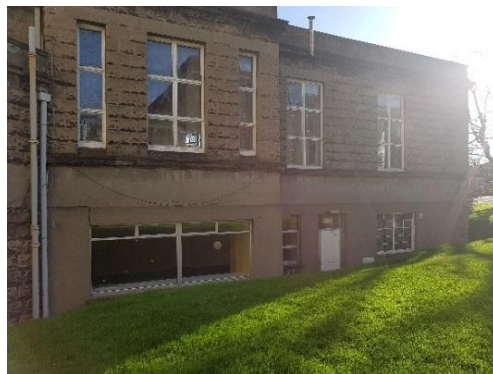
Fig. 46 View of west elevation

Fig. 47 View of west elevation

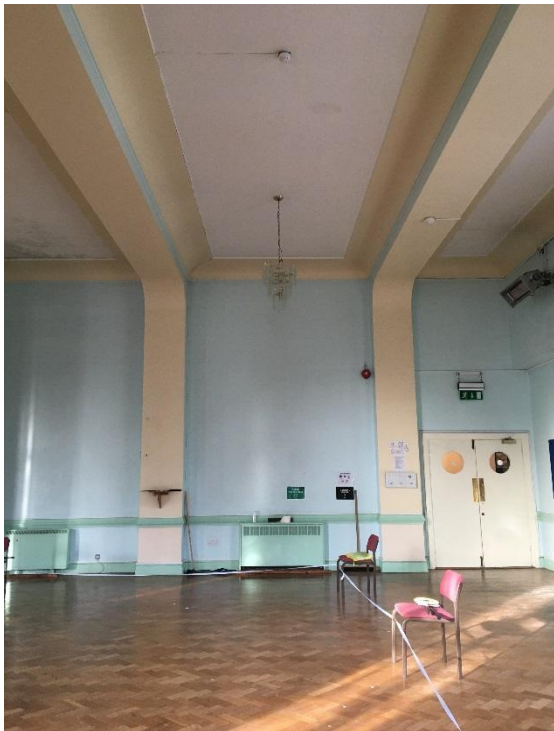
Fig. 48 Internal bay

This interior of the single volume hall is a well-crafted, simply designed structure of the mid-20<sup>th</sup> century. The space is divided into two with an innovative sliding door system. The building is unique in the complex in that whilst it is connected with Milltown Park House as its primary entrance, it has

independent access to the east in an expressed porch and lobby. The building is much altered from its original form.

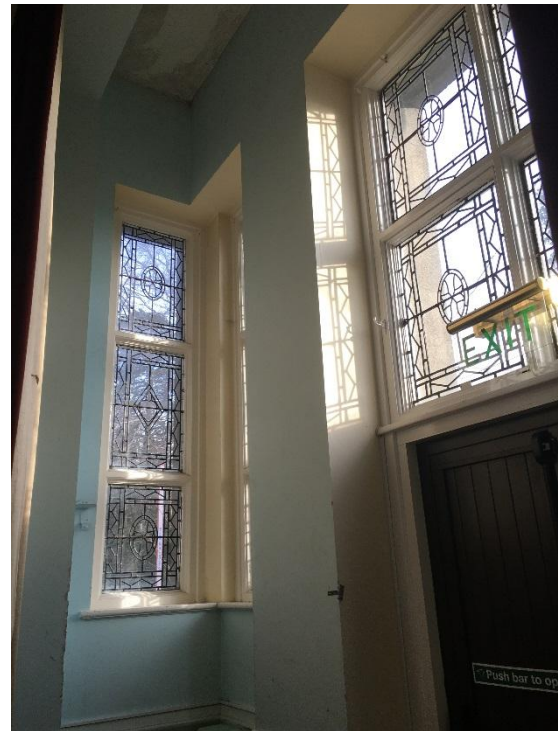
Fig. 49 Leaded windows within lobby to east

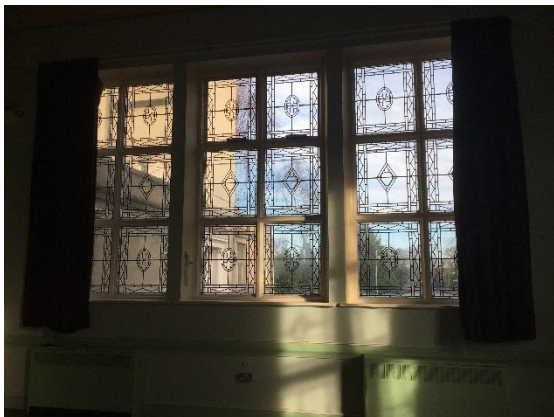
Fig. 50 North elevation leaded window

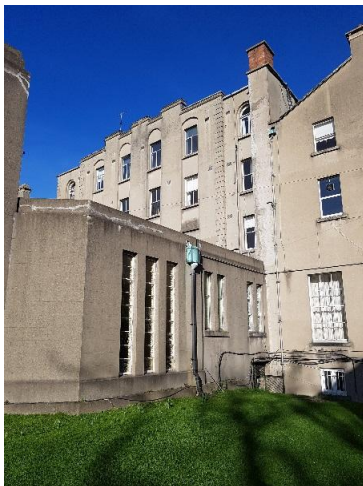
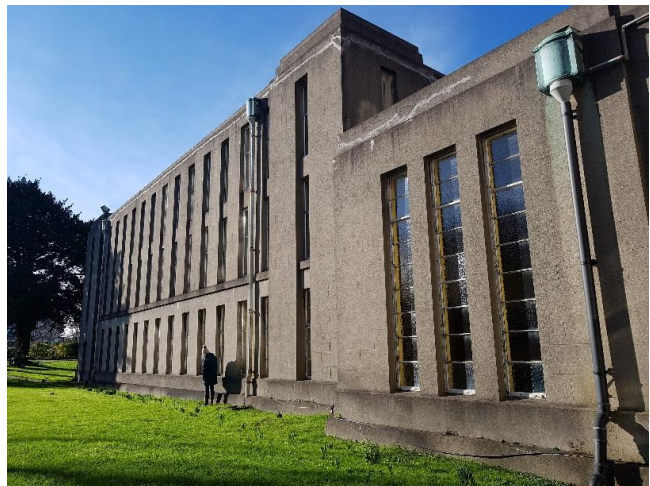
The Archive building's modest exterior, comprising a simply rendered concrete block building belies its crafted interior. Its external composition is representative of wartime Ireland where materials and labour were in sparse supply. Fenestration comprises horizontal metal frames in vertical bands in rhythm puncturing an otherwise solid, simply cast façade. Each corner has a raised parapet and contrasting window treatment, with recessed plat bands within an elongated cut. Its lower level link building connecting with the Milltown Park House rear extension block, defers to its parent form.

Fig. 51 *East elevation in context with Extension Block*      Fig. 52 *East elevation*

Element	Composition	Condition	Comment
East elevation	The east elevation's cementitious rendered finish is punctured by tall two pane	Generally good.	The east elevation is a simple exercise in brutalism

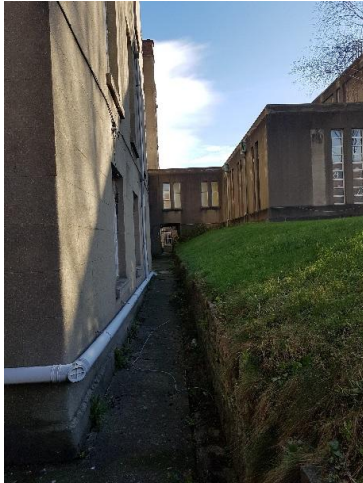
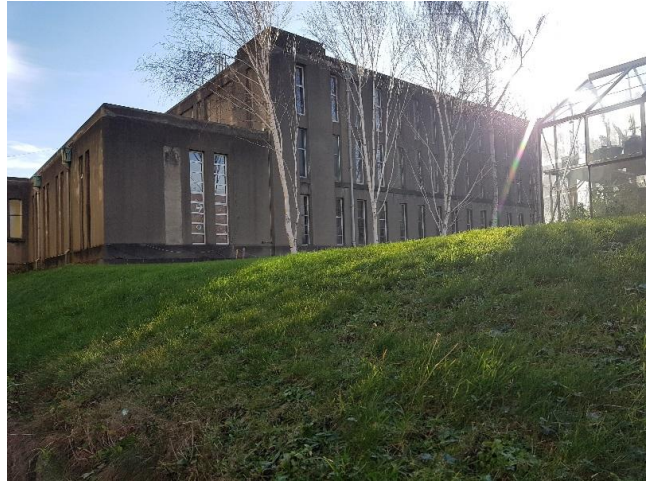
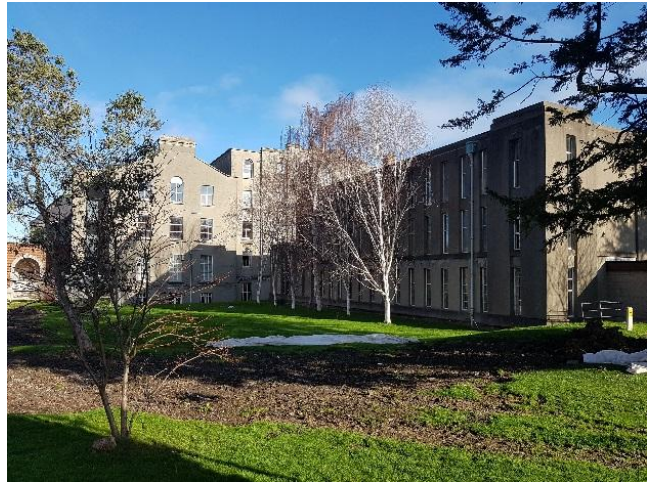
Fig. 53 *West elevation in context with Extension Block*

Fig. 54 *West elevation*

Fig. 56 *West elevation in context with Extension Block*

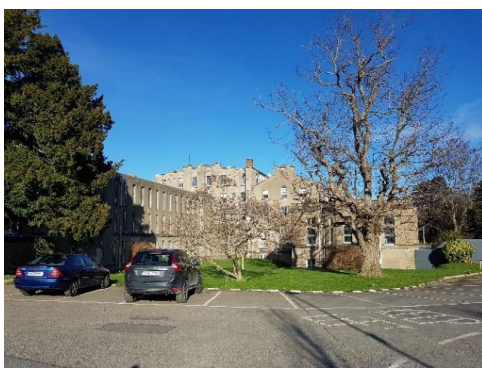
Fig. 57 *South elevation in context with the grouping*

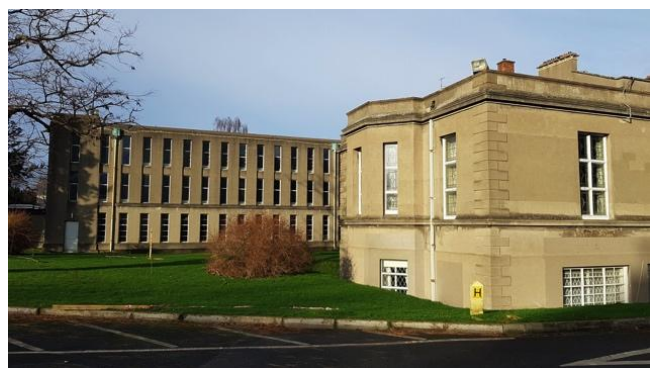
Fig. 58 *East elevation in context with the Finlay Wing*

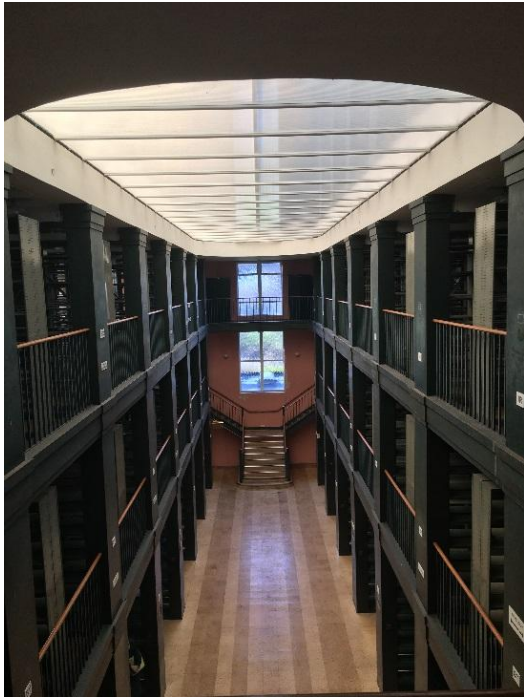
Fig. 59 Interior view, due south

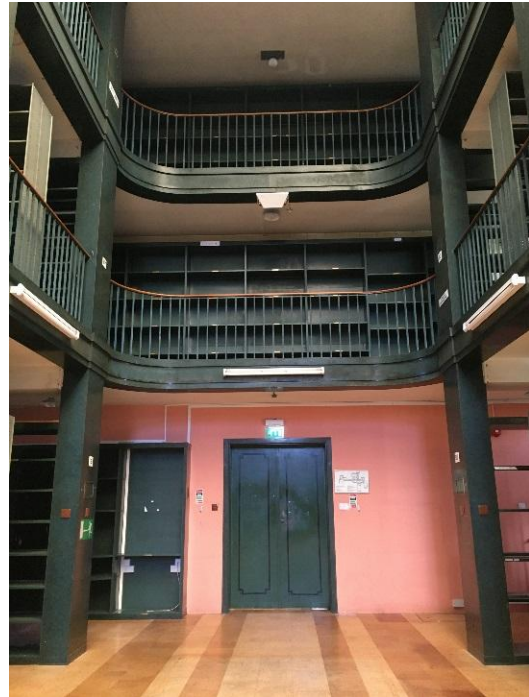
Fig. 60 View, due north

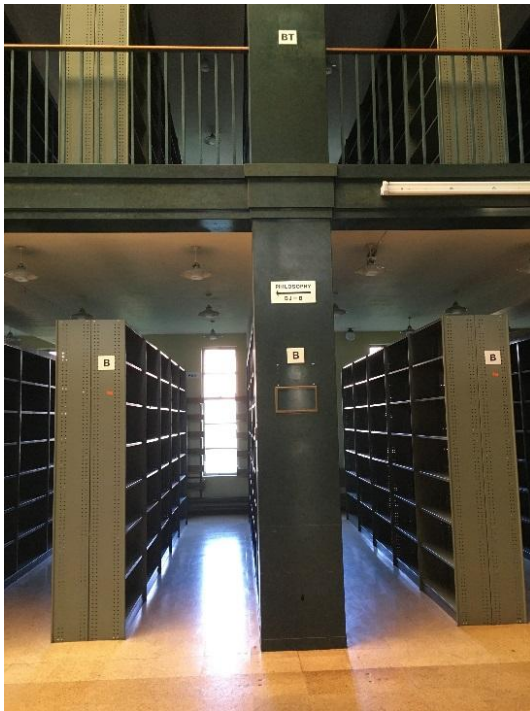
Fig. 61 Structure/ bookshelf bay composition

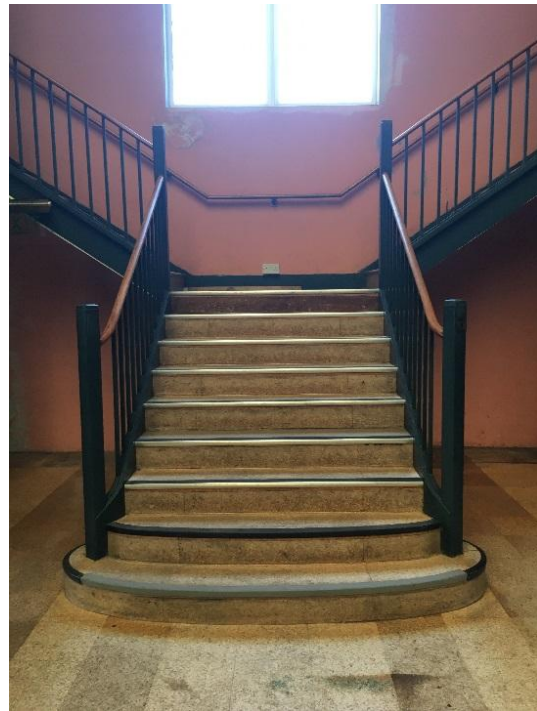
Fig. 62 Stair composition
