# **Appraisal Of Architectural Significance**

ATTACHED TO EIAR CHAPTER 7.0 ARCHITECTURAL HERITAGE

**MILLTOWN PARK, SANDFORD ROAD, DUBLIN 6**

July 2025

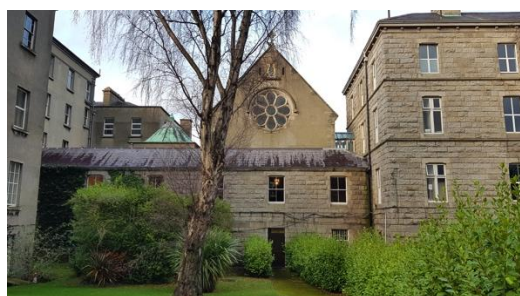
Fig. 63 East elevation

Element	Composition	Condition	Comment
East elevation	The east elevation is subsumed within the Tabor House link building, with roofing visible above.	Generally good.	The chapel is accessed modestly from the Tabor House link building, with no singular announcement of the quality of its interior evident externally.
West elevation	The west elevation is visible within the parkland	Generally good.	The west elevation is bow ended, cement

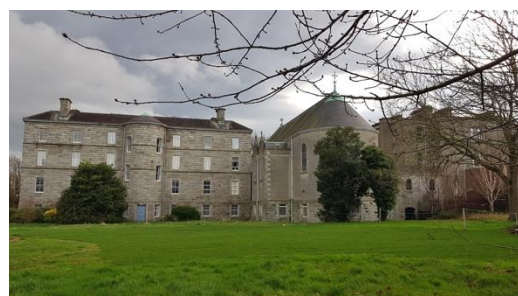
Fig. 64 West elevation in context

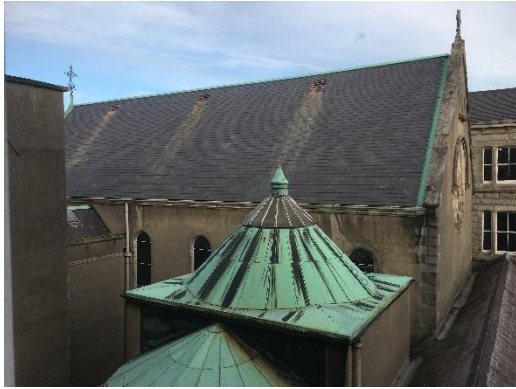
Fig. 65 South elevation

setting.		rendered with a rusticated granite plinth.
<b>South elevation</b>	The southern elevation is visible only from upper level windows within the Milltown Park rear extension block.	Generally good.	The southern elevation is obscured by outbuildings and by its proximity to the extension to rear of Milltown Park House. It is similarly composed to the west elevation.
<b>North elevation</b>	The north elevation is obscured due to its proximity to Tabor House	Generally good.	The northern elevation is in close proximity to Tabor House and not visible only from the open space at garden level between the two buildings. It is composed similarly to the west elevation.
<b>Basement level</b>	A basement exists under the chapel, at garden level. It consists of cellular accommodation either side of a central corridor.	Rising damp is evident throughout. All fittings and finishes are intact with little evident of later intervention.	The fabric is generally intact.

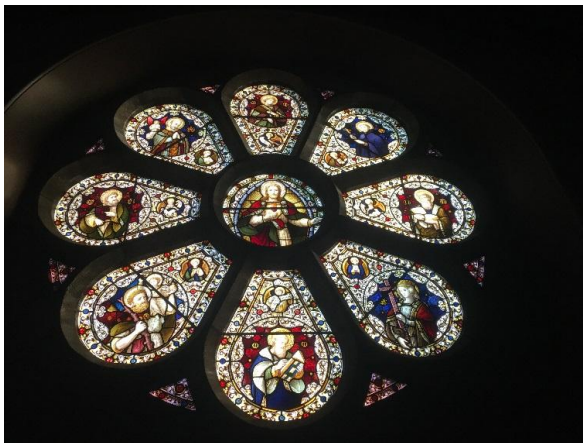
The interior is clad with polished marble wall and floor linings within a grid composition. Its expressed roof structure is a continuance of the grid. Whilst all pews have been removed, the interior reflects its ecclesial function, with a collection of stained glass windows by Clarke Studios and Mayer & Co. of Munich.

Fig. 67 Rose window above gallery

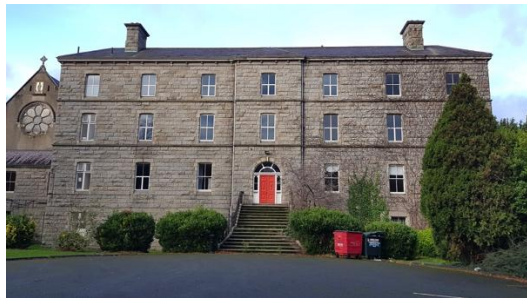
Tabor House comprises a three storey over basement building, and possesses a strong exterior of rusticated granite, with sweeping entrance steps centrally positioned to the east. It has a slated pitched roof, timber sash windows and timber panelled doors.

Fig. 68 East elevation

Element	Composition	Condition	Comment
East elevation	The building's east (front) elevation is compositionally pleasing, comprising a 7	Generally good.	The buildings presence is striking within the parkland

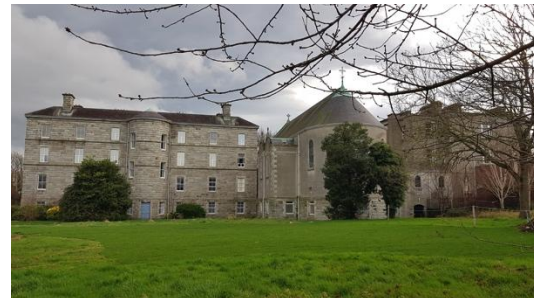
Fig. 69 West elevation in context

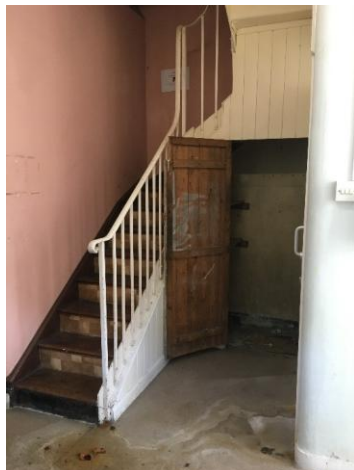
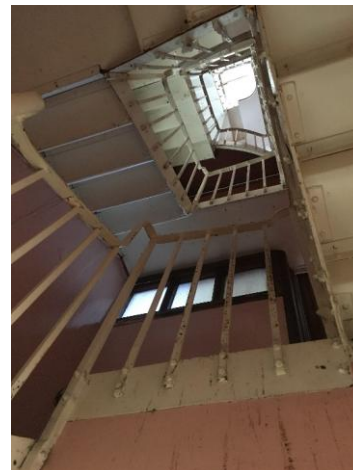
Fig. 70 Secondary steel stair of interest
