Residential-led Mixed-Use Development at Sandford Road, Milltown

Preliminary Design Stage Quality Audit

190226-X-90-X-XXX-RP-DBFL-CE-0004

December 2025

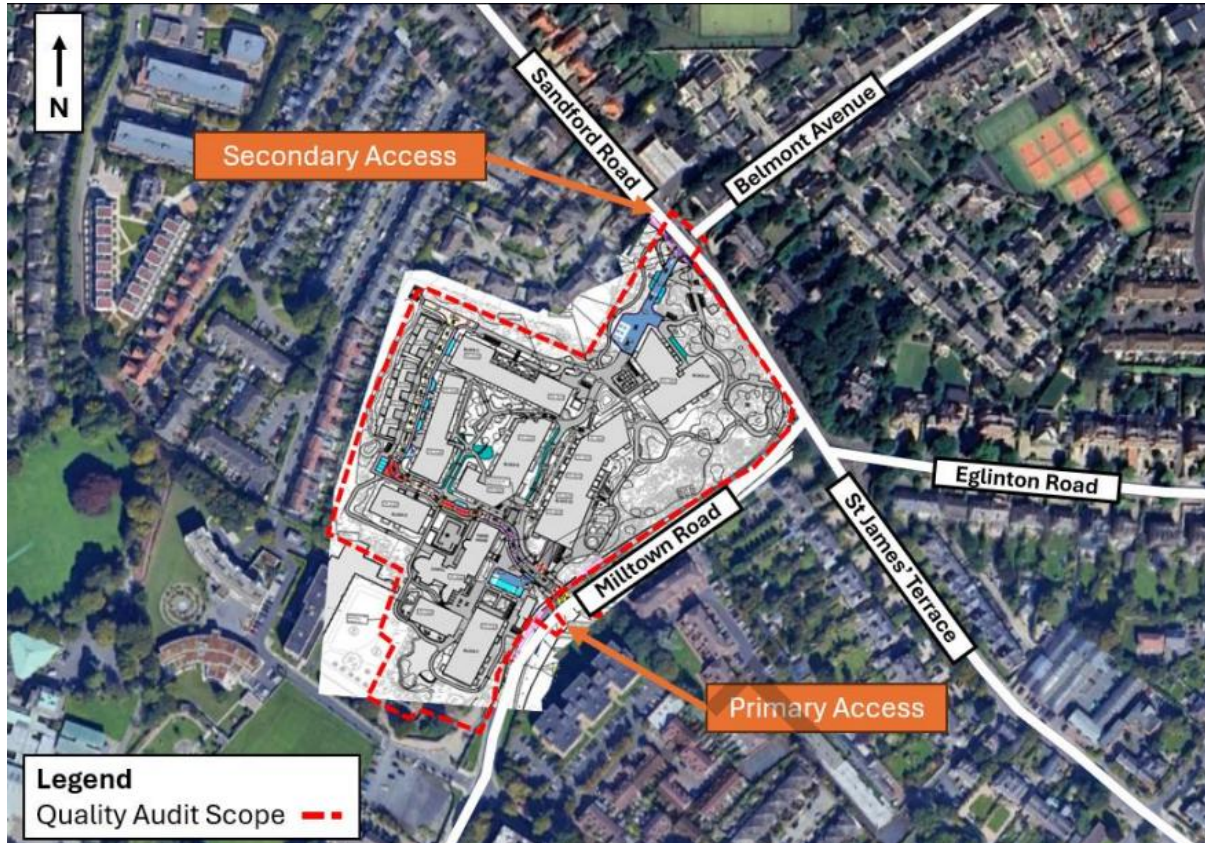
Figure 1-2: Geographical Scope of Quality Audit

The geographical scope of this Quality Audit considers the subject development site (extent of proposed new infrastructure works within the site boundary) which includes the proposed site

access/egress locations. In addition, the immediate pedestrian/cycle/vehicular routes leading to/from the development site have also been included within the Quality Audit. The geographical scope of this Quality Audit is illustrated in Figure 1-2 below.

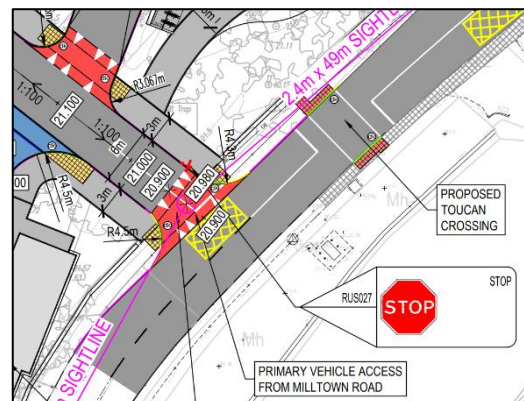
4.2.3 Location (S3) – Toucan Crossing

A toucan crossing is proposed to the north of the western site access. No transitions for cyclists are provided, and the footpath appears to be pedestrian only. A lack of transitions may cause cyclists to wait in the carriageway to cross at the toucan crossing, where they may be struck by vehicles.

It is recommended that transitions for cyclists should be provided at the toucan crossing, and that any shared areas should be marked as such, with appropriate tactile paving.

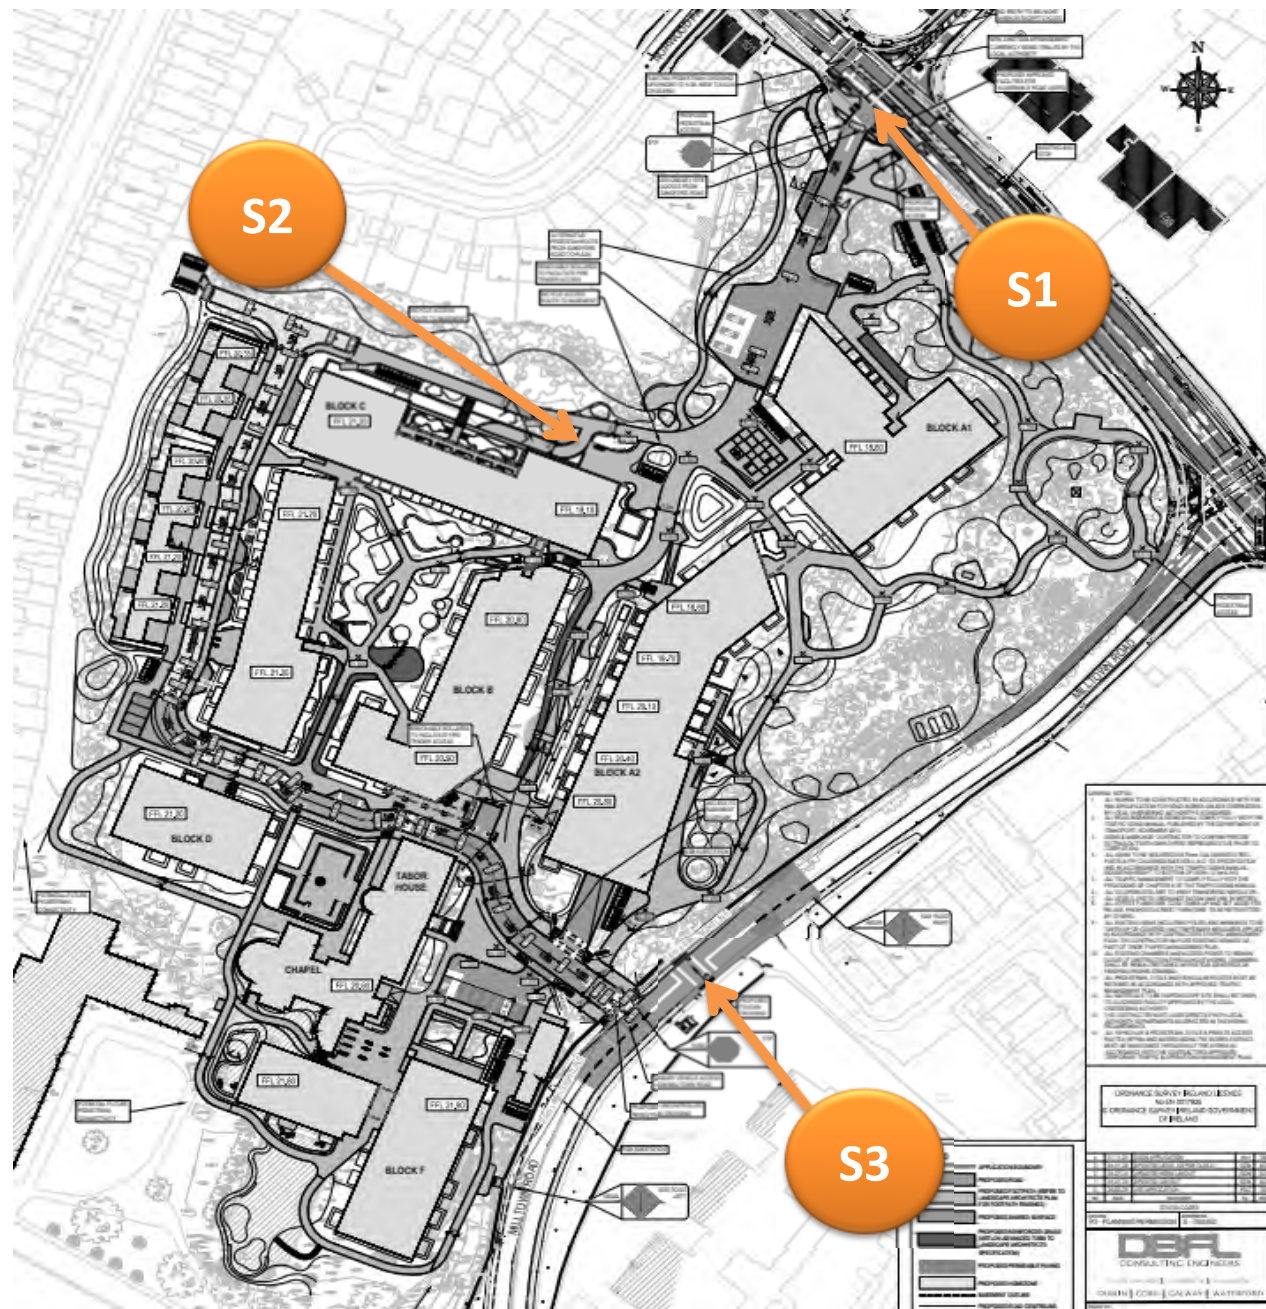
Appendix A : Problem Location Map

Project :	Sandford LRD	Designed :	RB	Prepared:	RB
Client :	Sandford Living Limited	Date :	November 2025	Checked :	SAS
Drawing Title :	Quality Audit Problem Locations	Scale :	NTS

***Note: For general problems, examples of locations are indicated. Not all occurrences of the specific general problem reference are shown**
