Proposed Residential-Led Mixed-Use Development, Sandford Road, Dublin 6

Site Specific Flood Risk Assessment

190226-X-X-X-XXX-RP-DBFL-CE-0003

December 2025

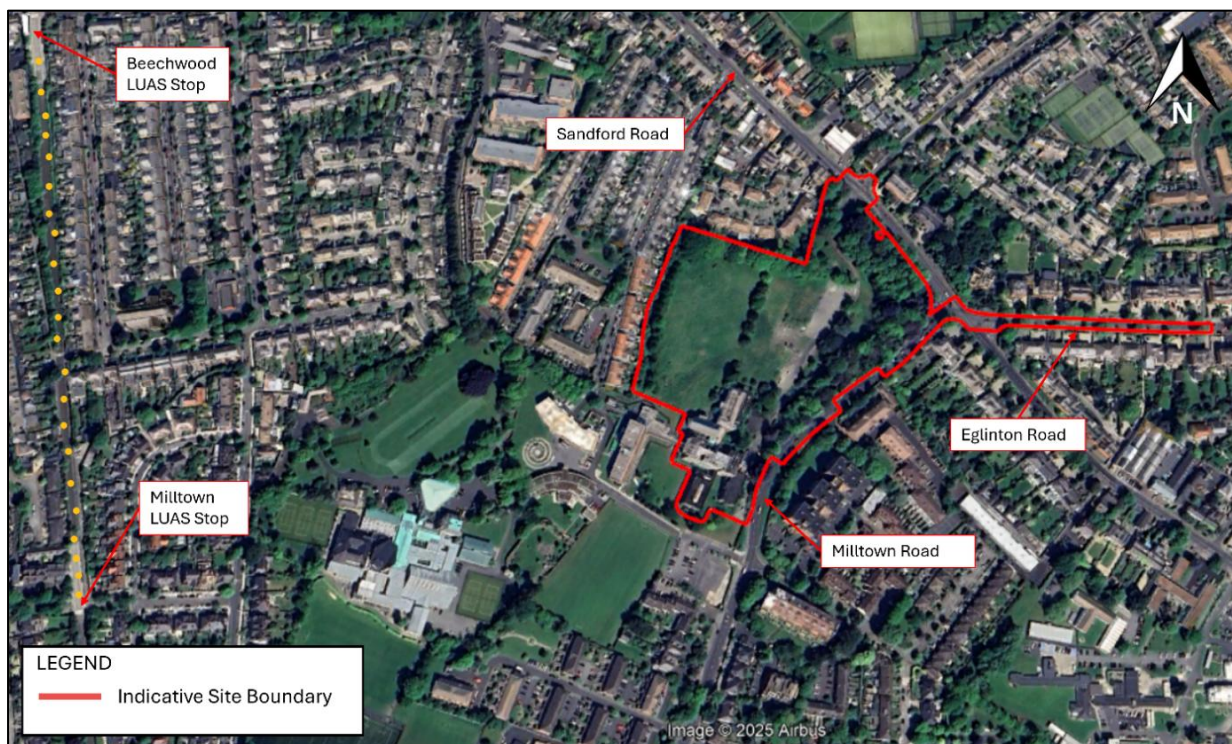
Figure 1-1 Site Location (Site Boundary Indicative Only)

The subject site is located at the corner of Sandford Road and Milltown Road (refer to Figure 1-1 below). The site is currently occupied by vacant buildings, two of which are to be retained within the proposed development (The Chapel and Tabor House). The subject site includes the extent of Eglinton Road that will be impacted during the reconstruction of the existing surface water sewer that serves as the outfall for the overall development.

Sandford Road is located along the site's north-eastern boundary and Milltown Road is located along the site's south-eastern boundary. Existing residential developments are located to the north-west and west of the site while lands in the ownership of the Jesuit Order are located to the south of the site.
