**Ground Investigations Ireland
Sandford Park Milltown**

**Ground Investigation Report
October 2020**

Project Title	Sandford Park Milltown
Engineer	DBFL
Client	DBFL
Project No	9338-12-19
Document Title	Ground Investigation Report

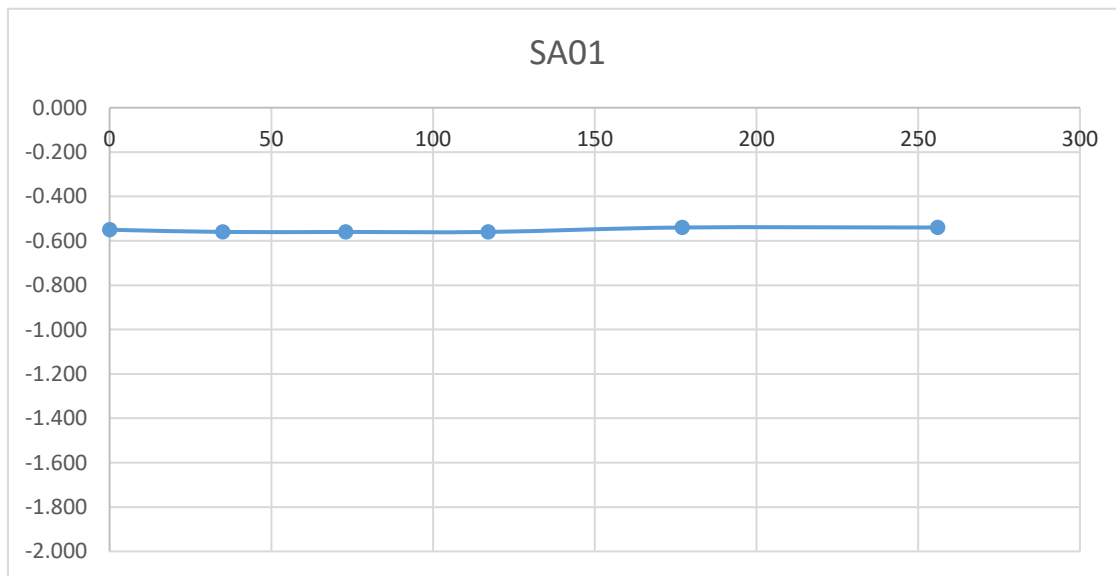
***Soakaway failed - Pit backfilled**

Start depth	Depth of Pit	Diff	75% full	25%full
0.55	2.500	1.950	1.0375	2.0125

At the locations of SA01, SA02 and SA03 the water level dropped too slowly to allow calculation of 'f' the soil infiltration rate. These locations are therefore not recommended as suitable for soakaway design and construction.

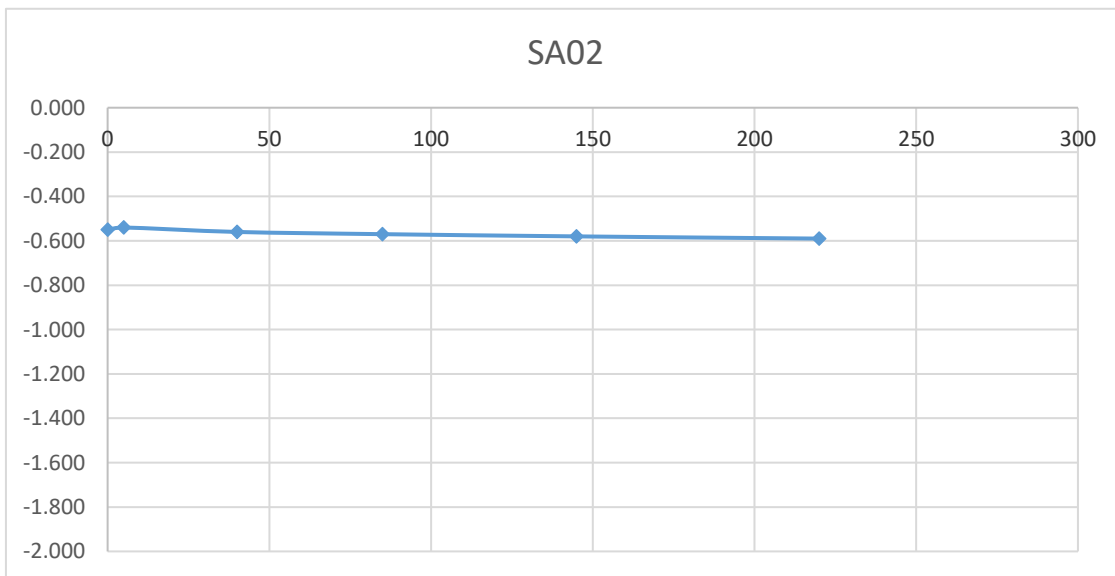
***Soakaway failed - Pit backfilled**

Start depth	Depth of Pit	Diff	75% full	25%full
0.55	2.500	1.950	1.0375	2.0125
